Corrosion Behaviour of Materials in High-Temperature Geothermal Environments

**Faculty of Industrial Engineering, Mechanical Engineering
and Computer Science
University of Iceland
2022**

Dissertation submitted in partial fulfilment of a
Philosophiae Doctor degree in Mechanical Engineering

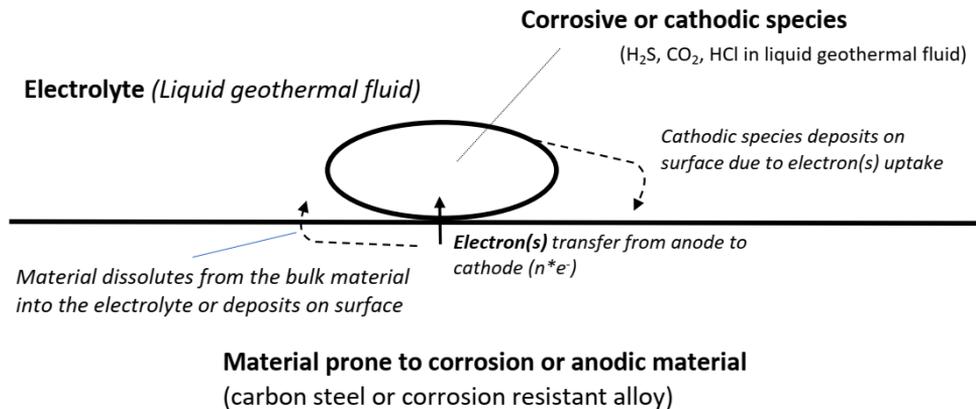
Figure 2 Schematic of wet corrosion mechanism

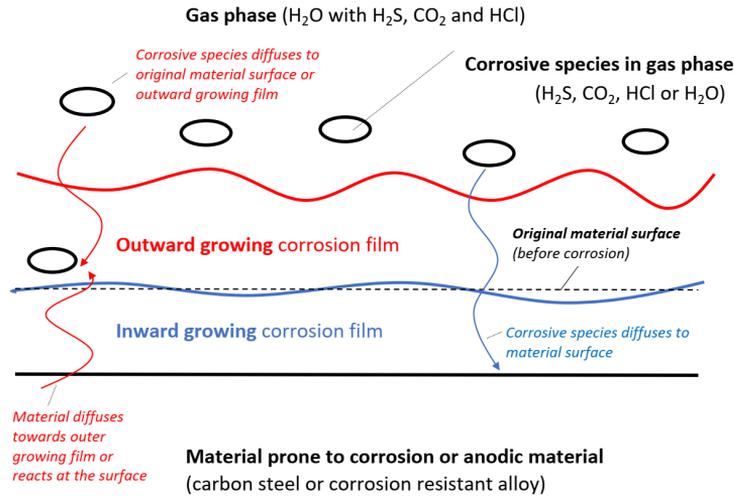
Figure 3 Schematic of the two dominant corrosion mechanisms for growth of corrosion film in dry corrosion

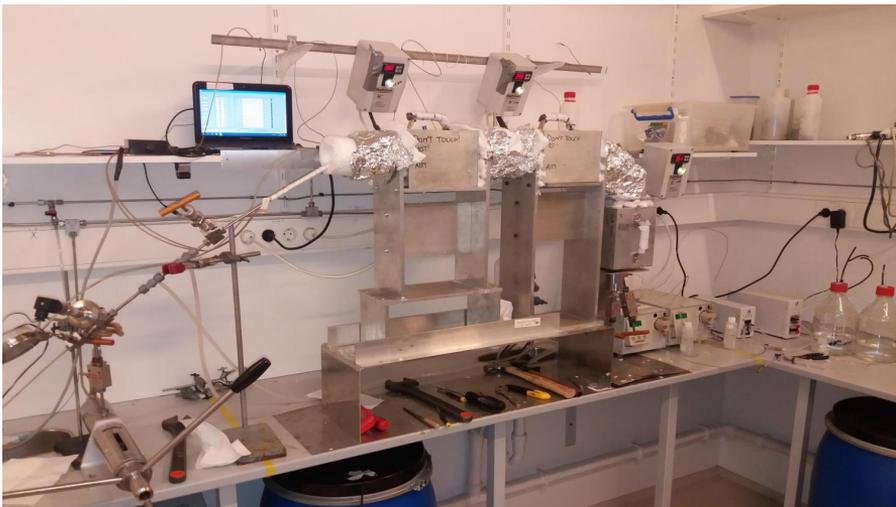
Figure 5 Test equipment for superhot test in all test volumes

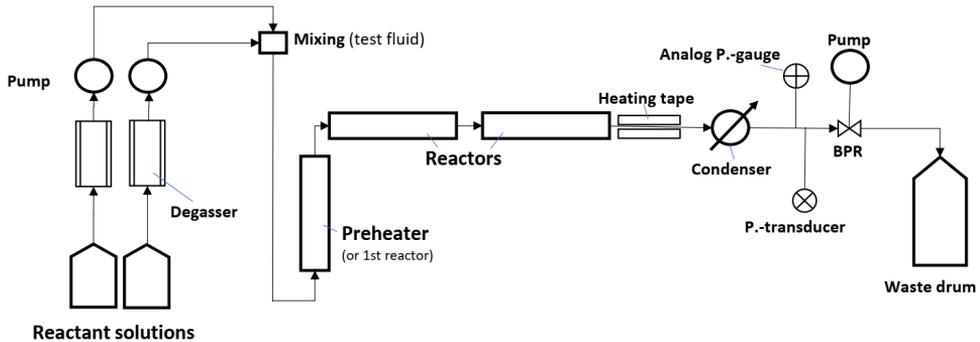
Figure 6 Simplified process flow diagram of the flow-through test setup

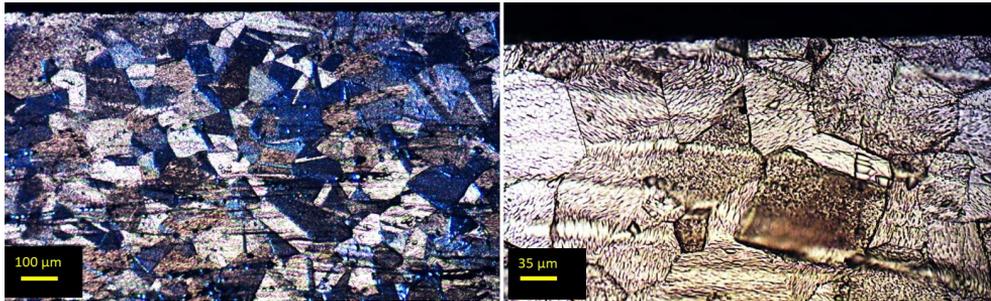
Figure 7 Etching of austenitic stainless steel UNS 31254 at two magnifications after test in superhot fluid at 350 °C and 10 barG with $H_2S = 150$ ppm and $CO_2 = 250$ ppm and pH = 3 upon condensation

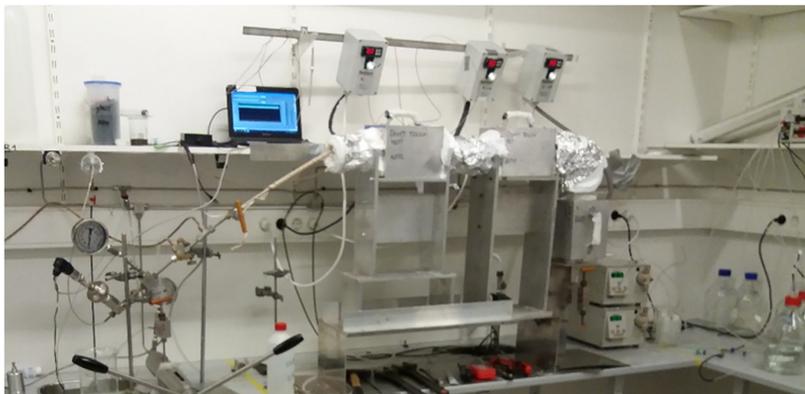
Fig. 1. Corrosion testing equipment setup.

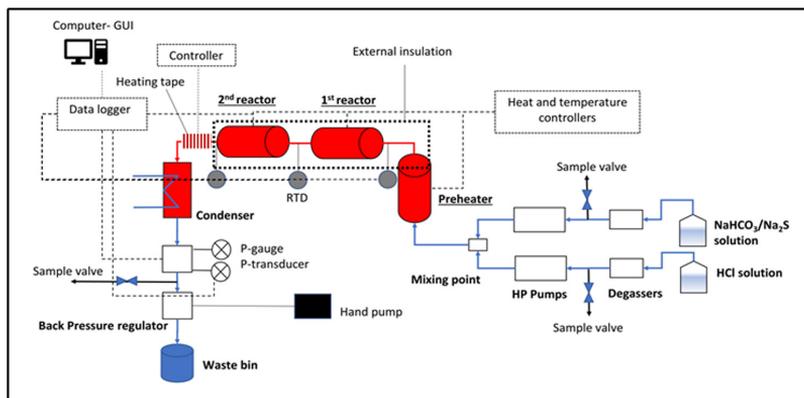
Fig. 2. Corrosion testing flow diagram.

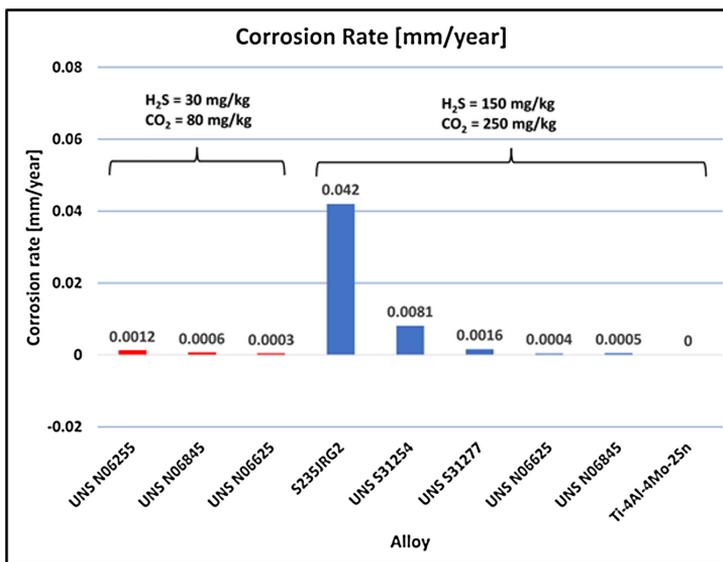
Fig. 3. Corrosion rate in low (H₂S = 30 mg/kg, CO₂ = 80 mg/kg) and high (H₂S = 150 mg/kg, CO₂ = 250 mg/kg).

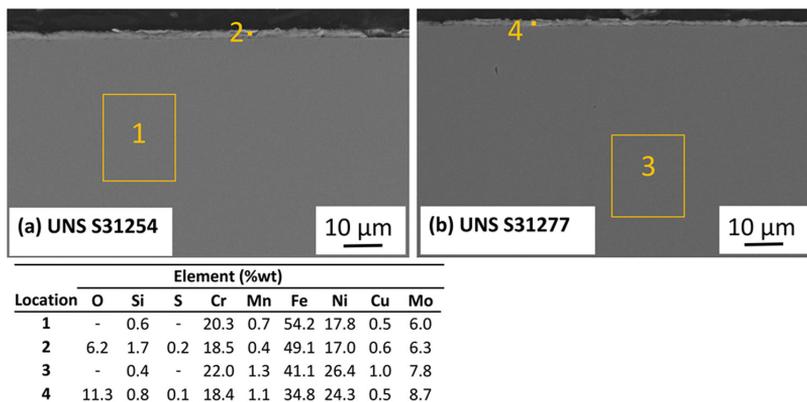
Fig. 5. SEM cross section images and XEDS analysis of austenitic stainless steels (a) UNS S31254 and (b) UNS S31277 in H₂S = 150 mg/kg and CO₂ = 250 mg/kg.

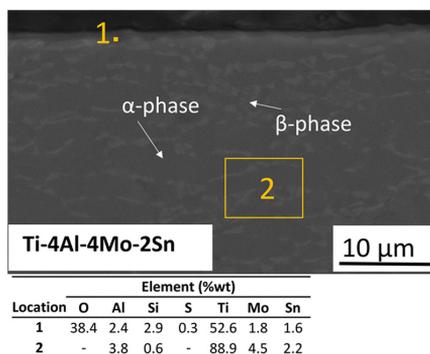
Fig. 7. SEM image of a cross section and XEDS analysis of titanium alloy Ti-4Al-4Mo-2Sn in H₂S = 150 mg/kg and CO₂ = 250 mg/kg.

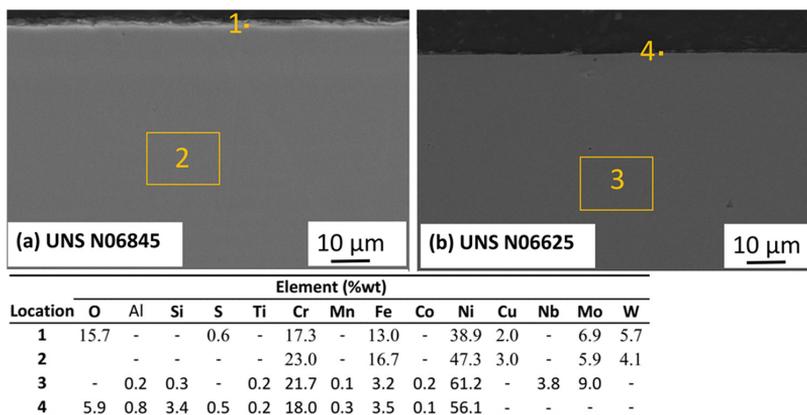
Fig. 6. SEM cross section images and XEDS analysis of nickel-based alloys (a) UNS N06845 and (b) UNS N06625 in H₂S = 150 mg/kg and CO₂ = 250 mg/kg.

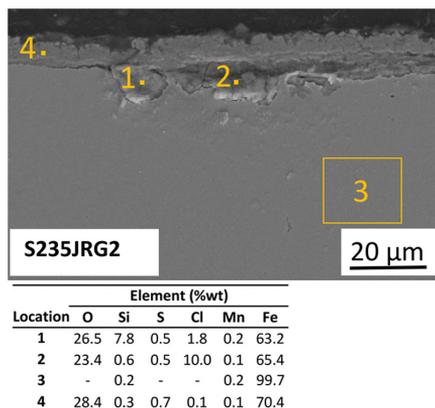
Fig. 8. SEM images and XEDS analysis of a cross section of carbon steel S235JRG2 in $H_2S = 150$ mg/kg and $CO_2 = 250$ mg/kg.

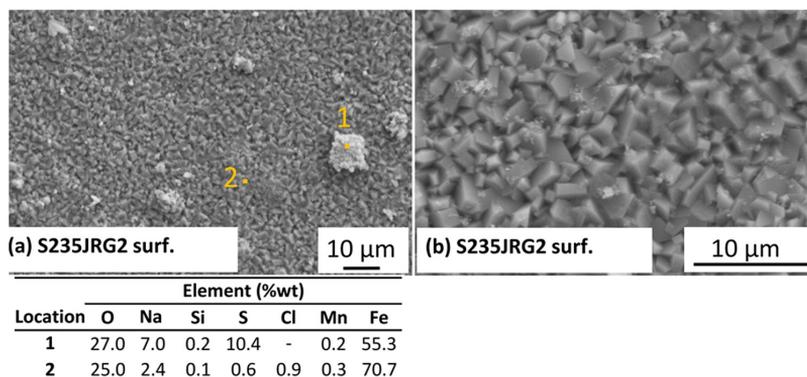
Fig. 9. SEM images and XEDS analysis on external surface of carbon steel S235JRG2 in $H_2S = 150$ mg/kg and $CO_2 = 250$ mg/kg at (a) low magnification and (b) at higher magnification.

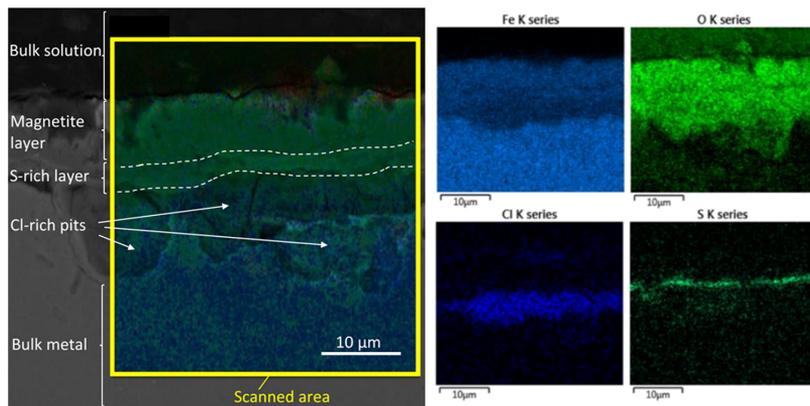
Fig. 10. SEM scanning image (left) of cross section of carbon steel S235JRG2 of oxide layer, sulphur layer and pits profile in the carbon steel in $H_2S = 150$ mg/kg and $CO_2 = 250$ mg/kg. The elemental profile for Fe, O, Cl and S from yellow frame from image (left) can be seen in smaller images at right. (For interpretation of the references to colour in this figure legend, the reader is referred to the web version of this article).

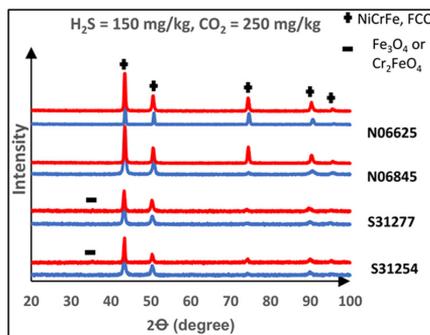
Fig. 12. XRD analysis of corroded (red) and blank (blue) austenitic stainless steels and nickel-based alloys samples in the higher concentration of H_2S/CO_2 testing. (For interpretation of the references to colour in this figure legend, the reader is referred to the web version of this article).

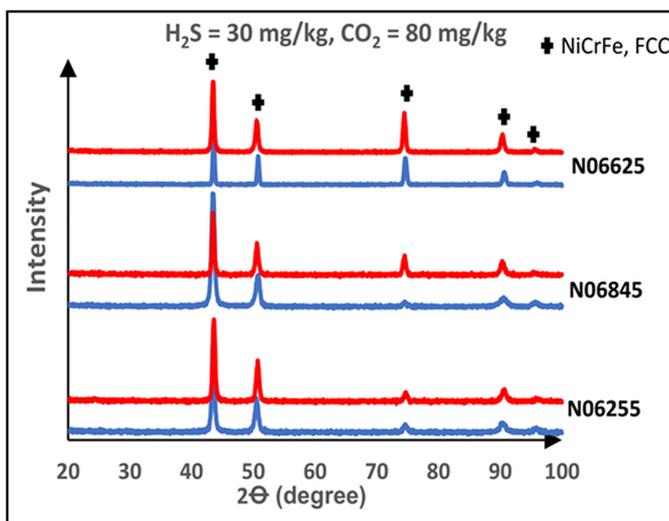
Fig. 11. XRD analysis of corroded (red) and blank (blue) nickel-based samples in the low H_2S/CO_2 concentration testing. (For interpretation of the references to colour in this figure legend, the reader is referred to the web version of this article).

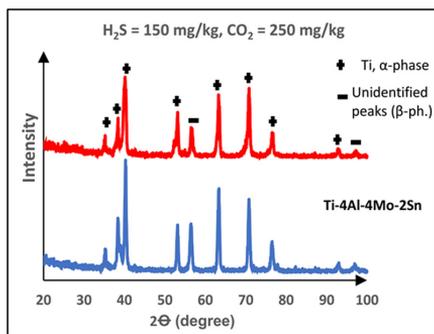
Fig. 13. XRD analysis of corroded (red) and blank (blue) titanium Ti-4Al-4Mo-2Sn samples in the higher concentration of H₂S/CO₂ testing. (For interpretation of the references to colour in this figure legend, the reader is referred to the web version of this article).

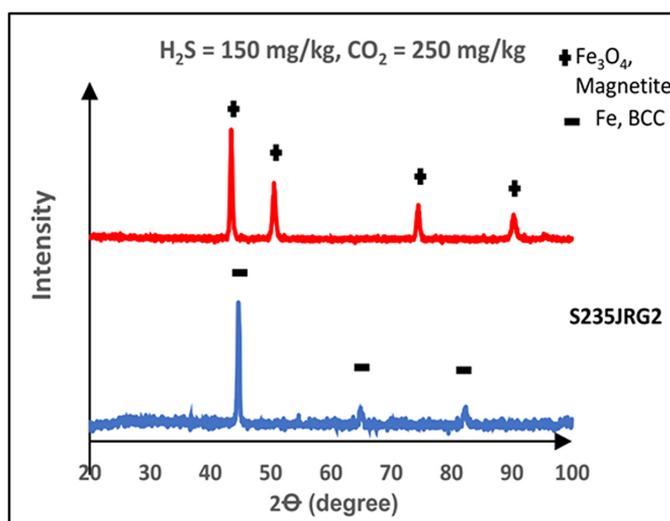
Fig. 14. XRD analysis of corroded (red) and blank (blue) carbon steel S235JRG2 samples in the higher concentration of H₂S/CO₂ testing. (For interpretation of the references to colour in this figure legend, the reader is referred to the web version of this article).

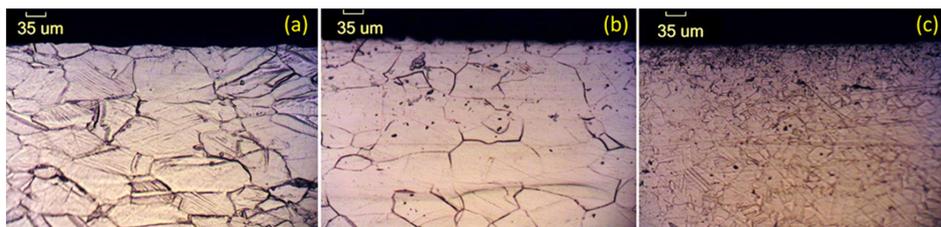
Fig. 15. Etching of (a) UNS N06255, (b) UNS N06845 and (c) UNS N06625 after testing in $\text{H}_2\text{S} = 30 \text{ mg/kg}$ and $\text{CO}_2 = 80 \text{ mg/kg}$.

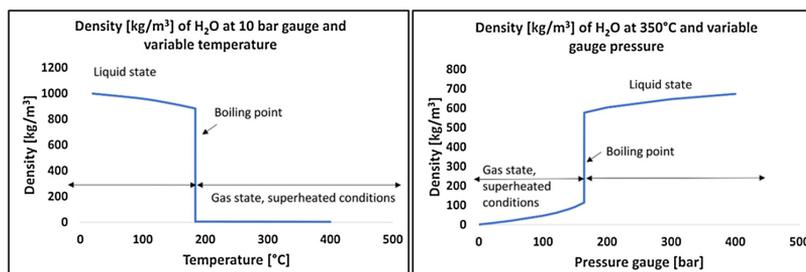
Fig. 16. Density of pure H_2O at 10 bar gauge vs. temperature (left) and density of H_2O at 350 °C vs. gauge pressure (right) with adapted data from [27]. Saturation point of pure water at 10 bar gauge is 184.1 °C and critical temperature of water is at 374 °C.

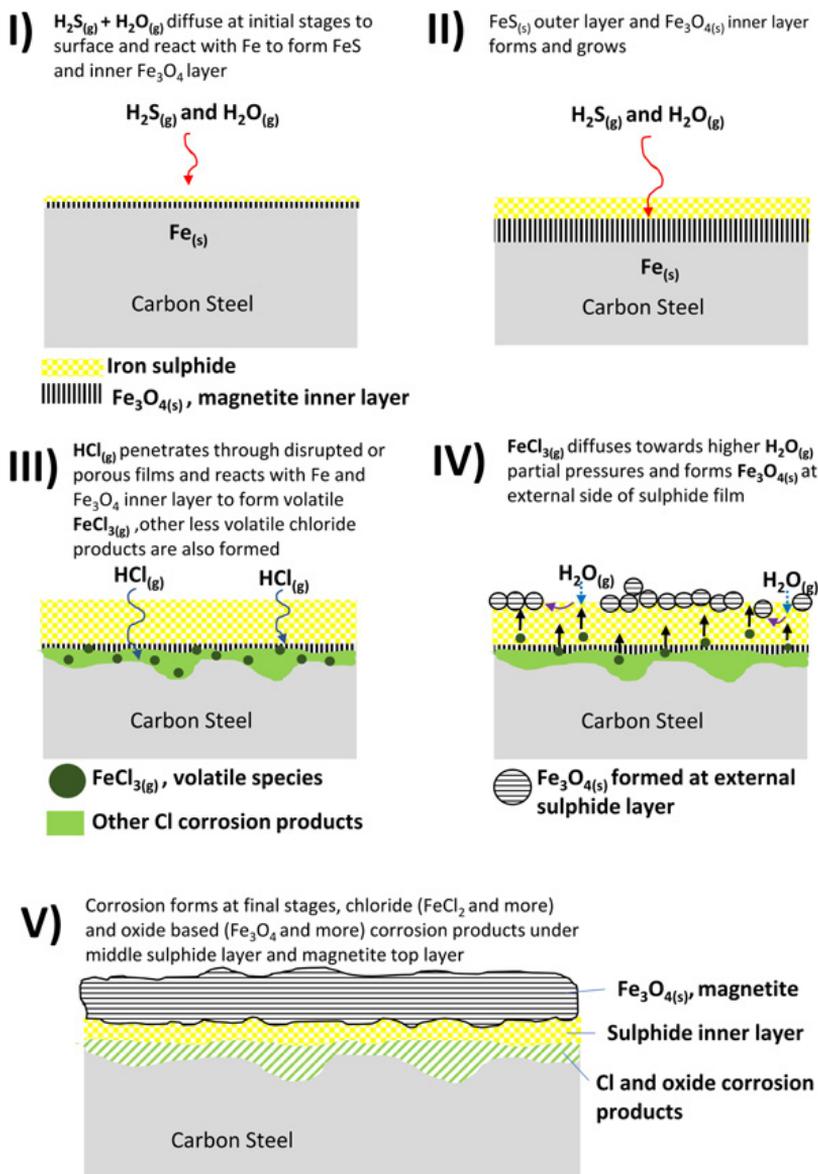
Fig. 17. Proposed mechanism of outer magnetite (Fe_3O_4) film formation, sulphide rich inner layer formation and chloride rich pit formation in carbon steel (S235JRG2) in the simulated geothermal environment.

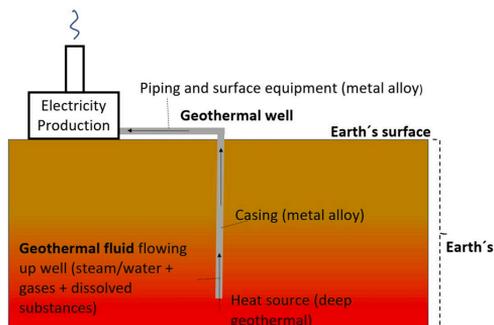
Fig. 1. Simplified geothermal well system.

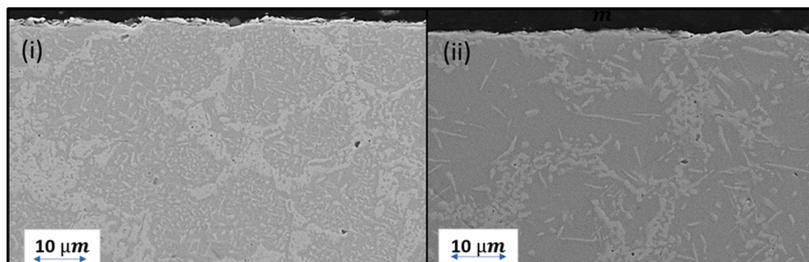
Fig. 2. Untested samples of (i) HEA4 and (ii) HEA5. Mo rich phases (light) and Ni-Fe rich phases (dark) were observed in all six sample types but with different morphology.

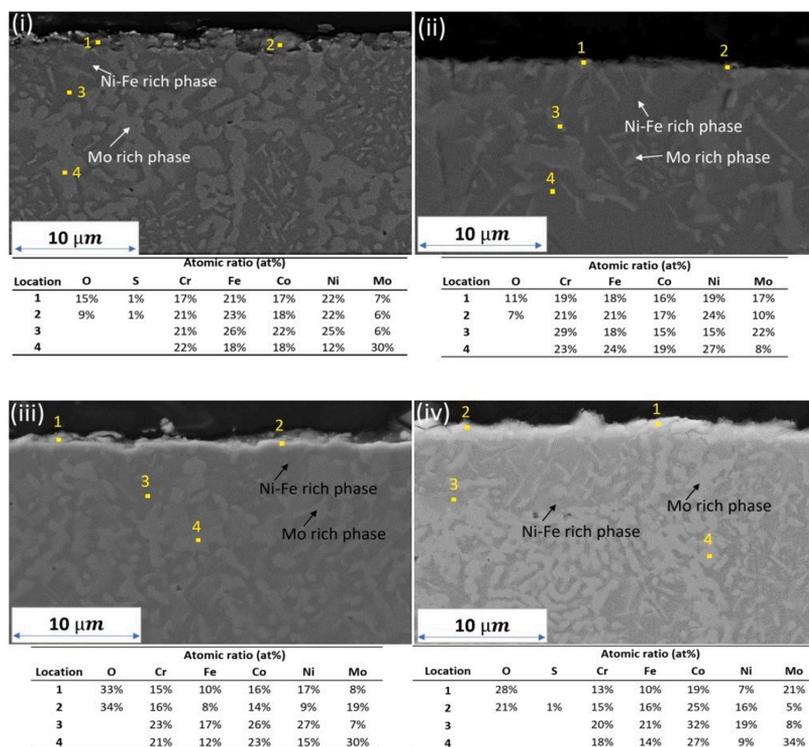
Fig. 3. Cross-section of tested samples of (i) HEA1, (ii) HEA2, (iii) HEA3 and (iv) HEA4.

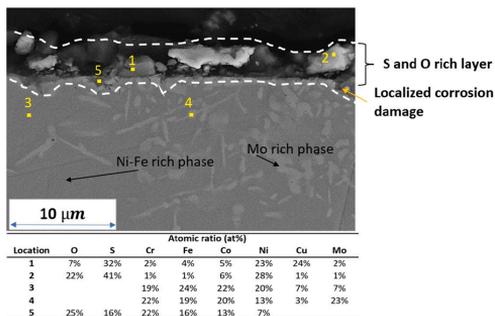
Fig. 4. Cross-section of tested HEA5 sample. The surface corrosion layer is rich of S and O and some indications of localized damage at early stages at the bulk alloy surface.

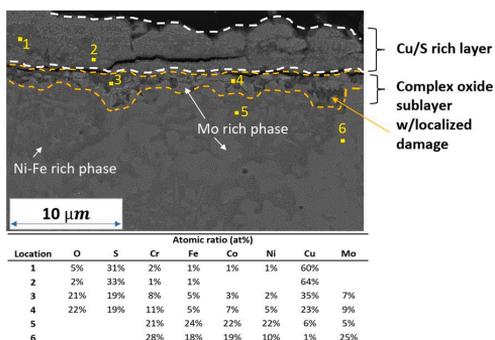
Fig. 5. Cross-section of tested HEA6 sample. The outer corrosion layer is rich of S and Cu but the sublayer rich of both S and O. Localized damage occurs at the sublayer in the bulk alloy where the Ni-Fe rich phase corrodes but the Mo rich phase remains coherent with bulk.

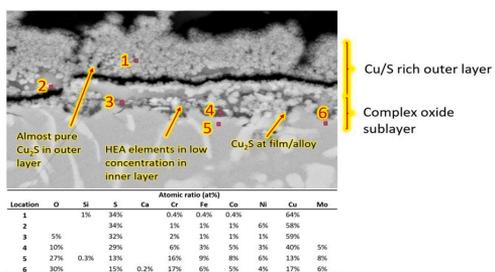
Fig. 6. BES image and XEDS analysis of tested HEA6 at high magnification.

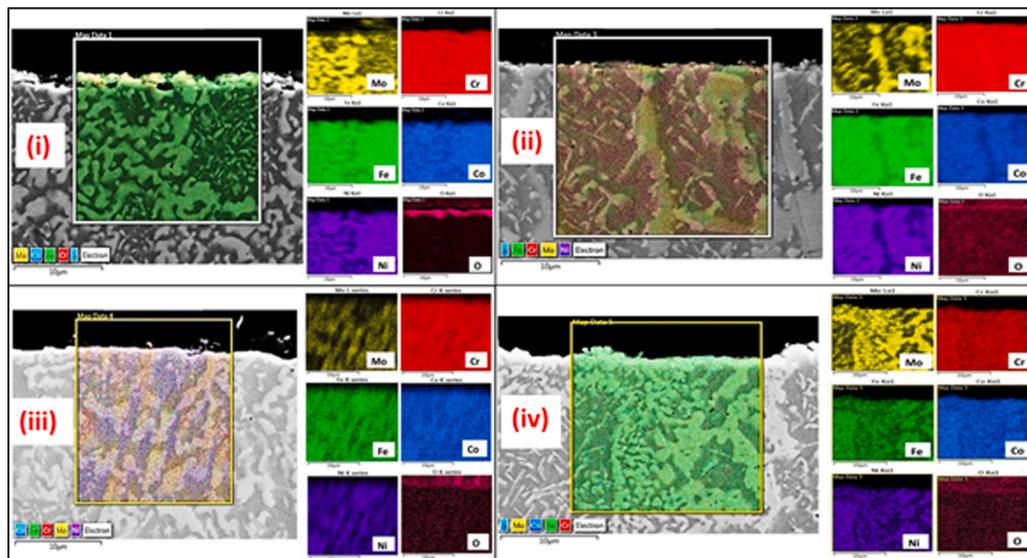
Fig. 8. Elemental mapping of the cross-section of the tested samples (i) HEA1, (ii) HEA2, (iii) HEA3 and (iv) HEA4. More oxide was observed on the surface of HEA1 in comparison with the other alloys.

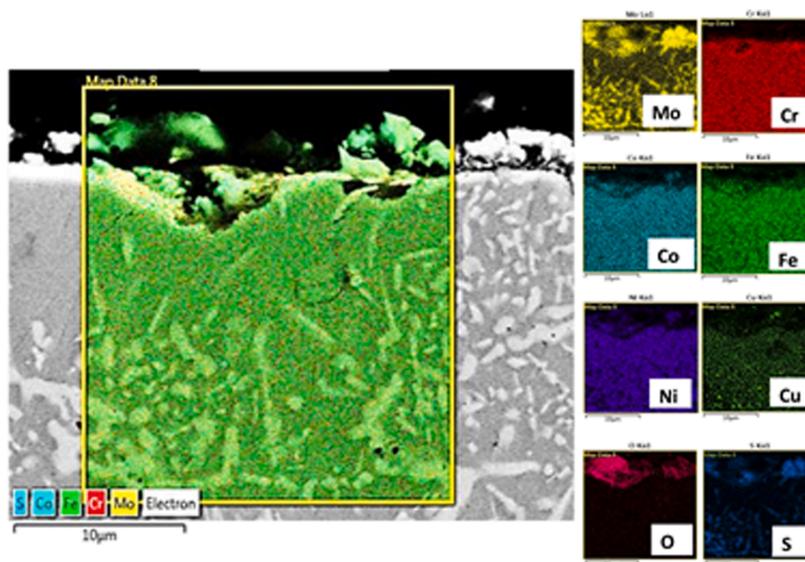
Fig. 9. Elemental mapping of the tested HEA5.

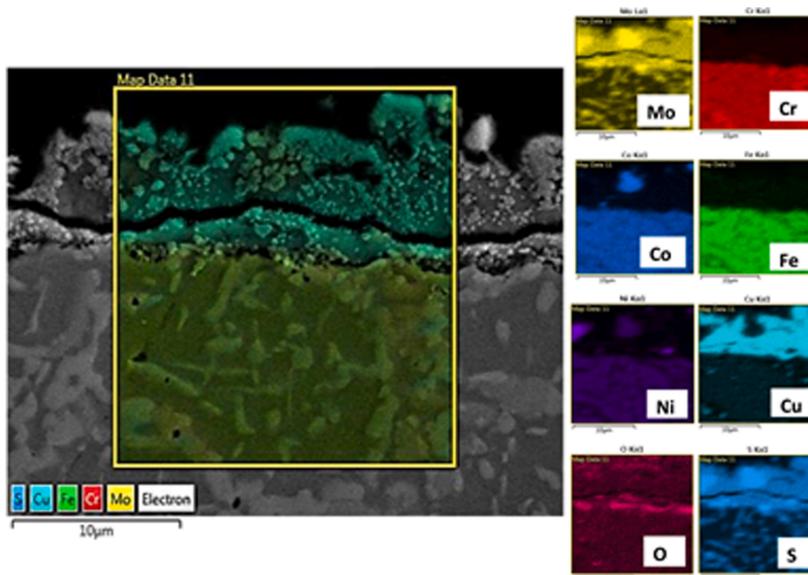
Fig. 10. Elemental mapping of the tested HEA6. The more concentrated and denser sulphur outer layer and concentrated oxide sublayer were observed in the Cu added HEA6 in comparison with the Cu added alloy HEA5.

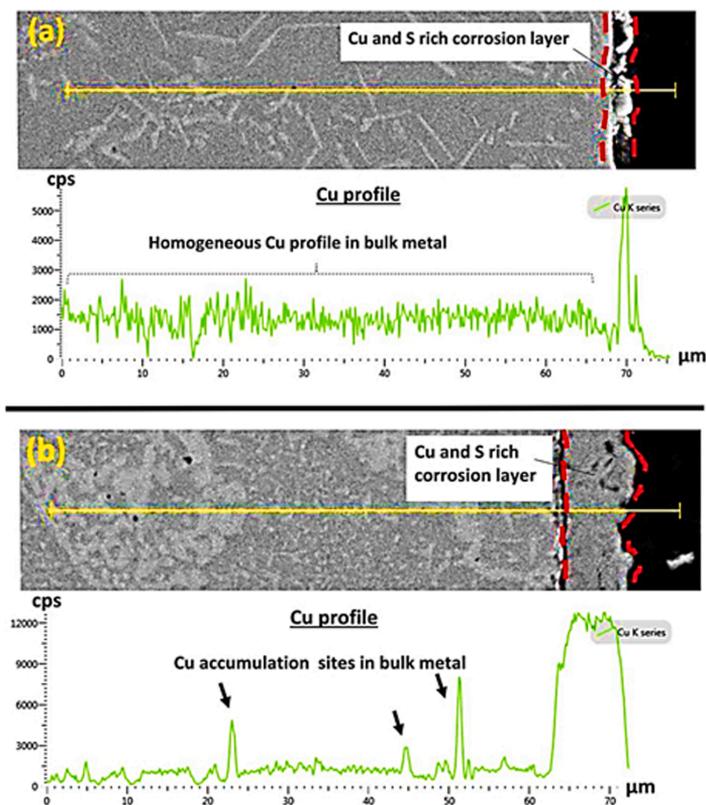
Fig. 11. Cu profile in a) HEA5 and b) HEA6. More segregation of Cu was observed in the higher Cu content HEA6 in comparison with HEA5.

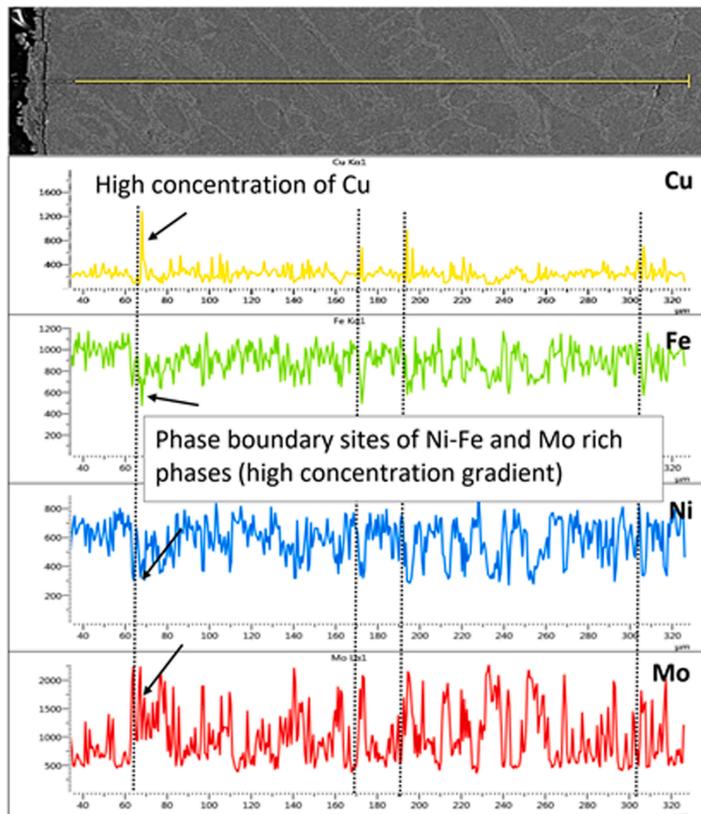
Fig. 12. Correlation between Cu concentrated sites in HEA6 and Ni-Fe and Mo concentration via elemental scanning along the yellow line (top). Cu concentration was high at apparent phase boundaries of Ni-Fe and Mo rich phases. (For interpretation of the references to colour in this figure legend, the reader is referred to the web version of this article.)

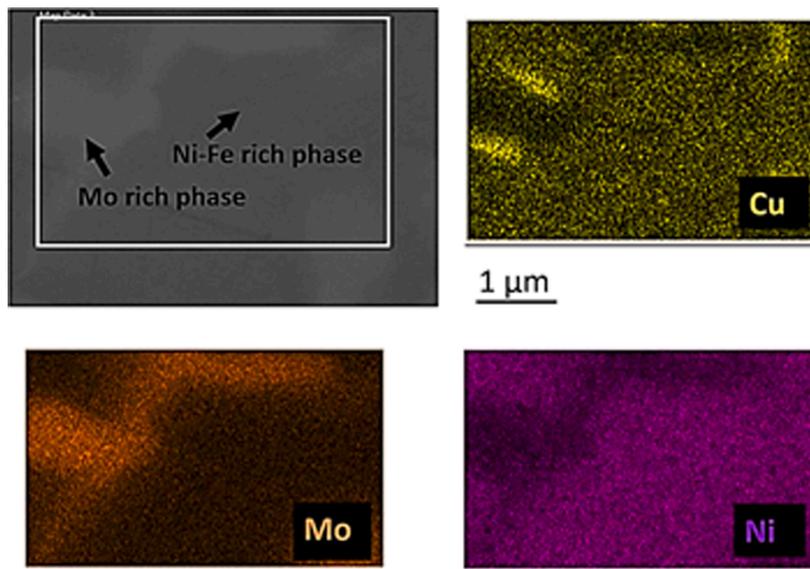
Fig. 13. Magnification of 20,000x in HEA6. Cu concentrated sites (strong yellow) were always observed at the phase boundaries of Ni-Fe and Mo rich phases. (For interpretation of the references to colour in this figure legend, the reader is referred to the web version of this article.)

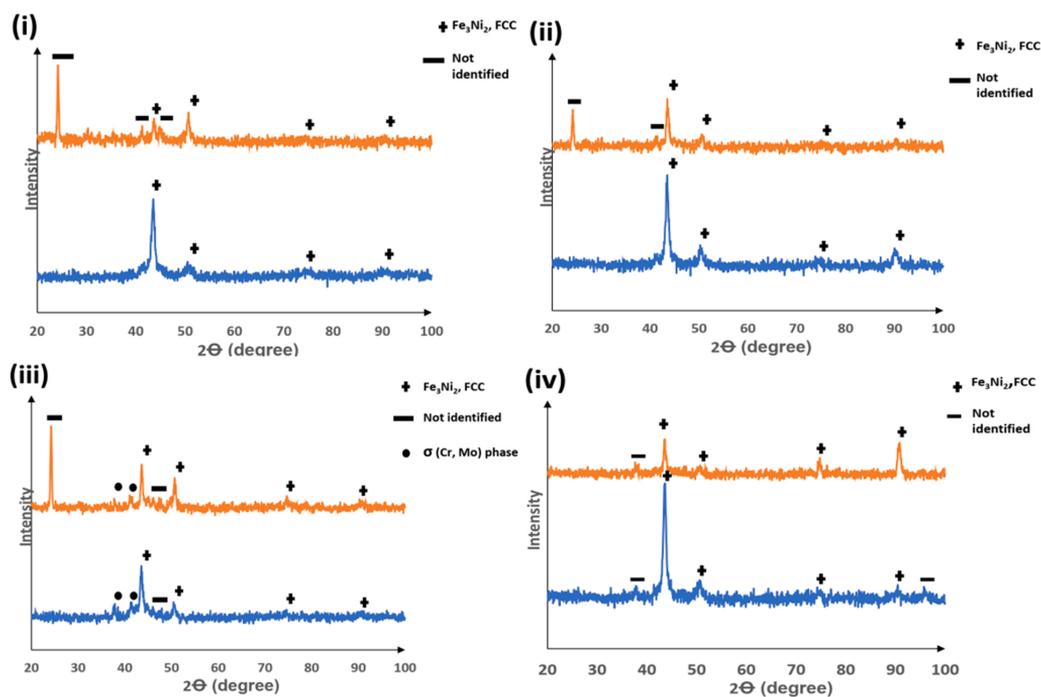
Fig. 14. XRD of tested (orange) and untested (blue) samples of (i) HEA1, (ii) HEA2, (iii) HEA3 and (iv) HEA4. (For interpretation of the references to colour in this figure legend, the reader is referred to the web version of this article.)

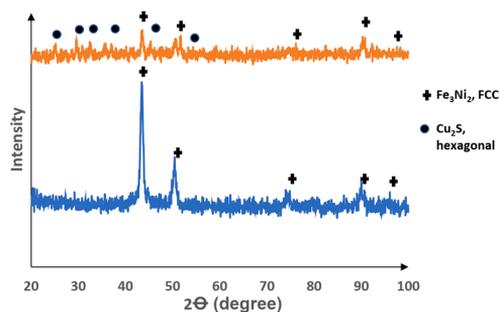
Fig. 15. XRD from tested (orange) and untested (blue) HEA5 samples. (For interpretation of the references to colour in this figure legend, the reader is referred to the web version of this article.)

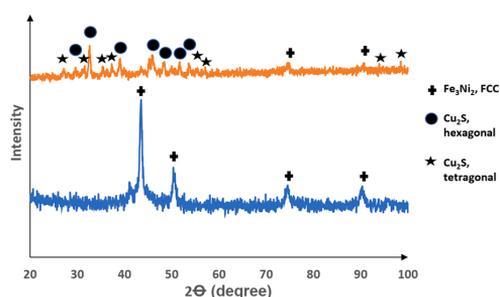
Fig. 16. XRD from tested (orange) and untested (blue) HEA6 samples. (For interpretation of the references to colour in this figure legend, the reader is referred to the web version of this article.)

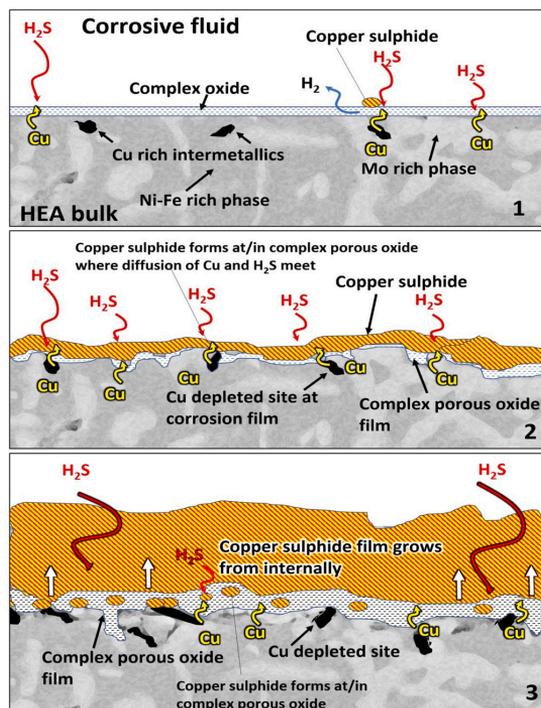
Fig. 17. 1) Cu diffuses through the preformed complex oxide layer. 2) Copper sulphide outer layer forms. 3) Copper sulphide film grows from the complex oxide layer.

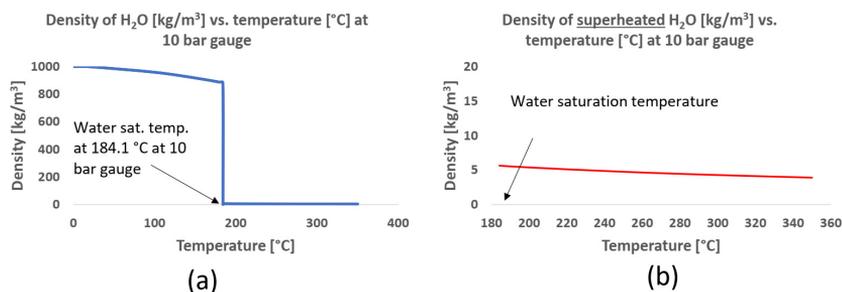
Figure 1. Density of pure H_2O at 10 bar gauge from (a) 0 to $350\text{ }^\circ\text{C}$ and (b) at superheated conditions ($>184.1\text{ }^\circ\text{C}$).

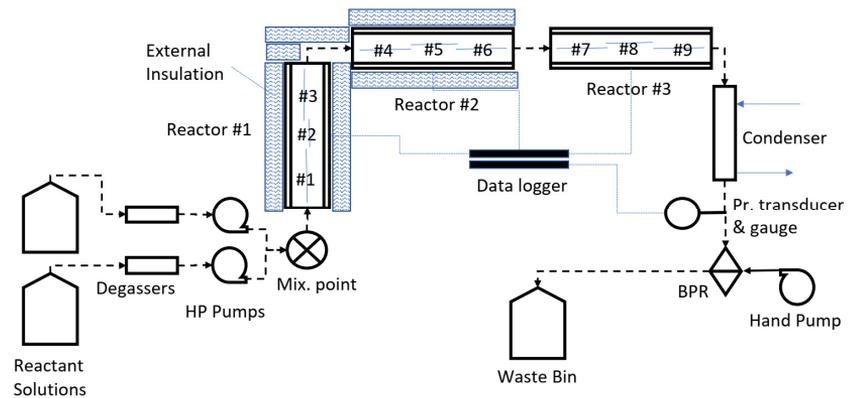
Figure 2. Flow diagram of the three reactors, flow-through testing facility. Three samples were accommodated in each reactor.

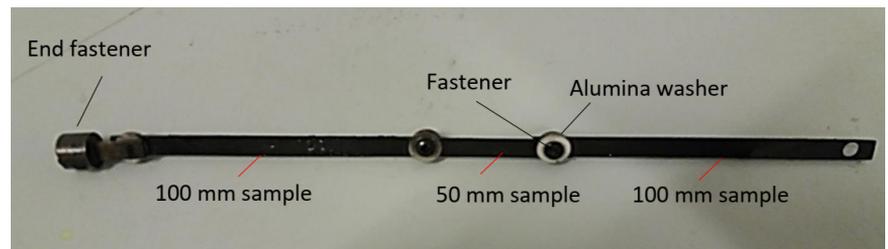
Figure 3. The carbon-steel samples in reactor 2 after the testing. All the carbon-steel samples in all three reactors had turned from shiny metal appearance to black appearance after the corrosion test.

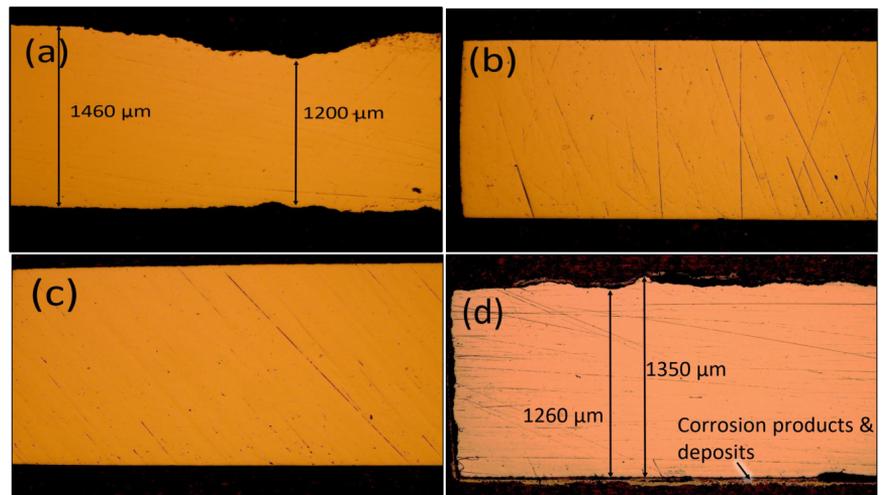
Figure 4. Optical microscope ($5\times$ magnification) of a carbon-steel sample cross-section (a) 1 cm from the inlet end of sample 1, (b) 3 cm from the inlet end of sample 1 in the first reactor, (c) In the middle of sample 5 in the second reactor and (d) one cm from the outlet end of sample 9 in the third reactor.

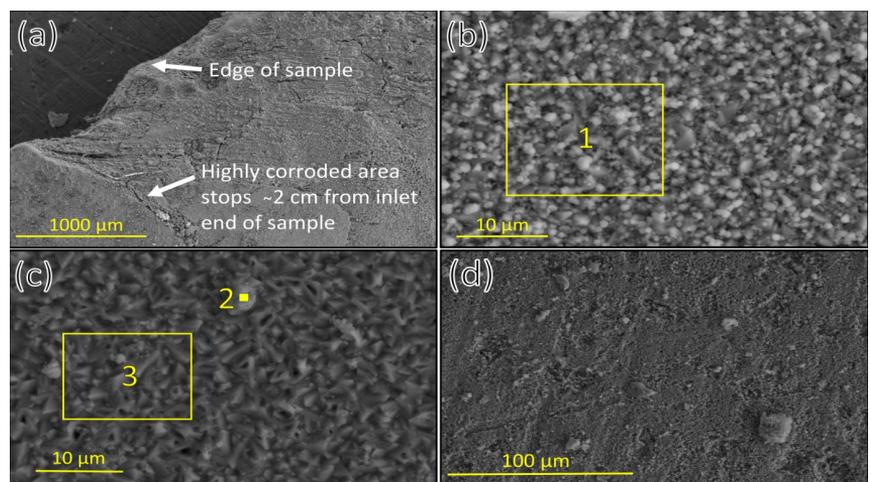
Figure 5. (a) Tested carbon-steel sample 1 only one cm from inlet end in the first reactor, (b) tested carbon-steel sample 1 now three cm from inlet end in reactor 1, (c) tested carbon-steel sample 5 in middle of the second reactor and (d) tested carbon-steel sample 9 at the outlet of the last reactor.

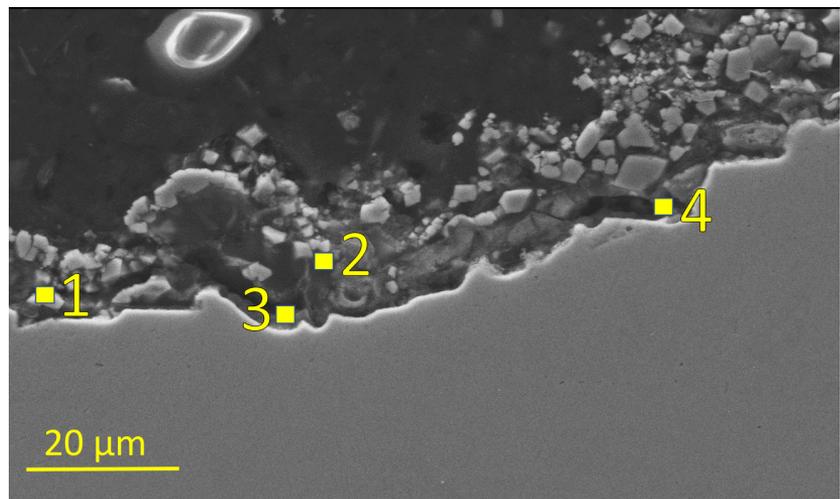
**Figure 6.** Cross-section of tested carbon-steel sample 1 one cm from the inlet of the first reactor.

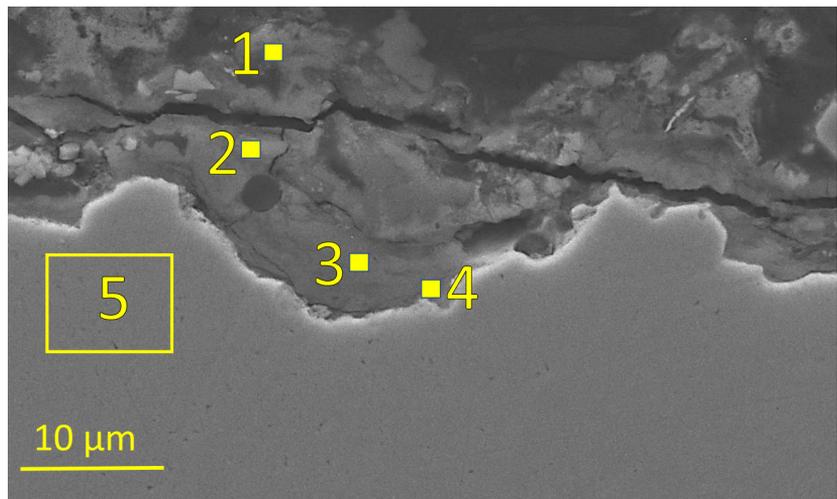
Figure 7. Cross-section of tested carbon-steel sample 1 one cm from the inlet of the first reactor. A continuous oxide layer was observed.

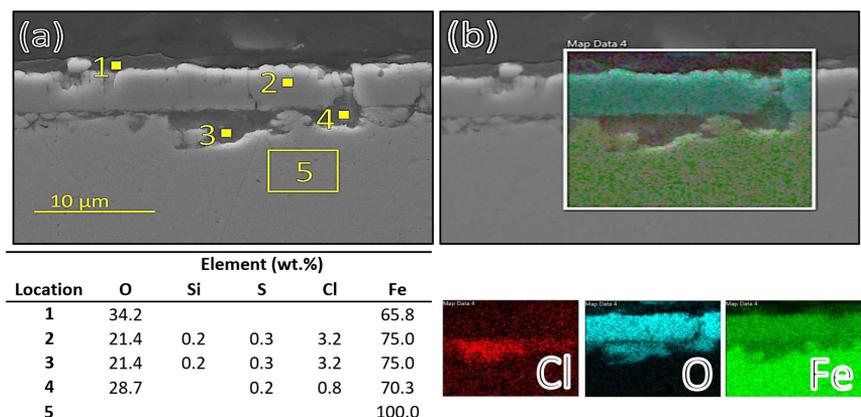
Figure 8. Cross-section of tested carbon-steel sample 1, three cm from the inlet of the first reactor with (a) localized chemical analysis and (b) elemental scanning.

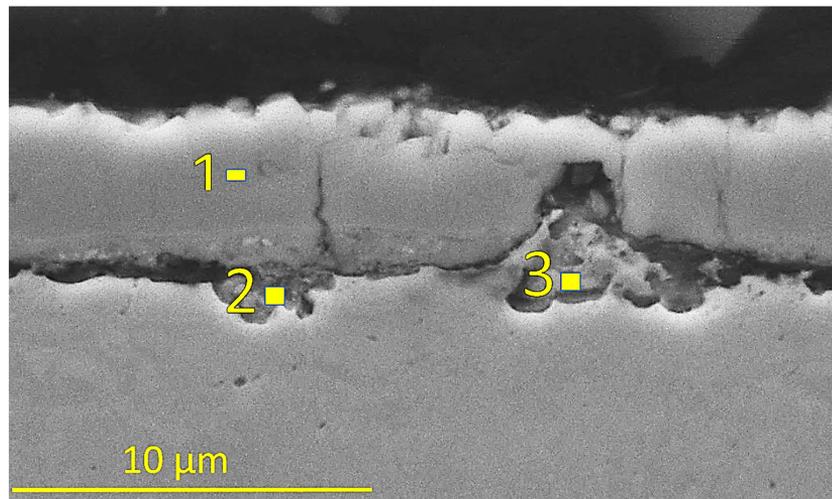
Figure 9. Cross-section in the centre of the tested carbon-steel sample 5 in the middle of the second reactor.

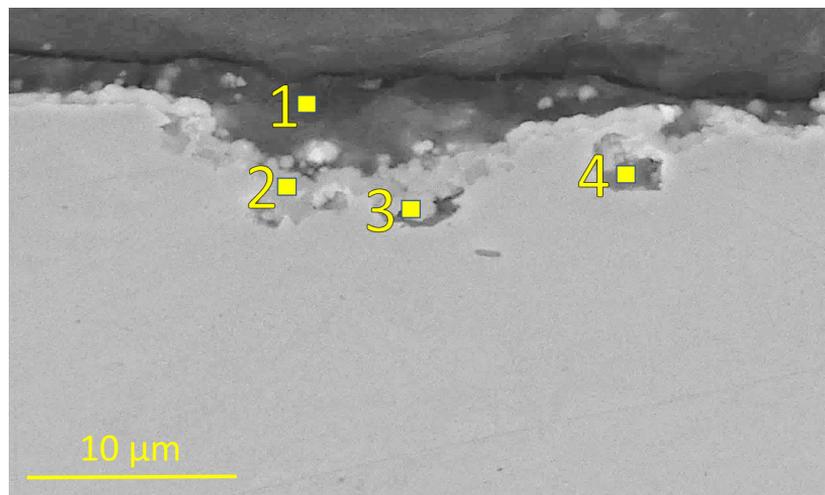
Figure 10. Cross-section in the centre of the tested carbon-steel sample 8 in the middle of the last reactor (condenser).

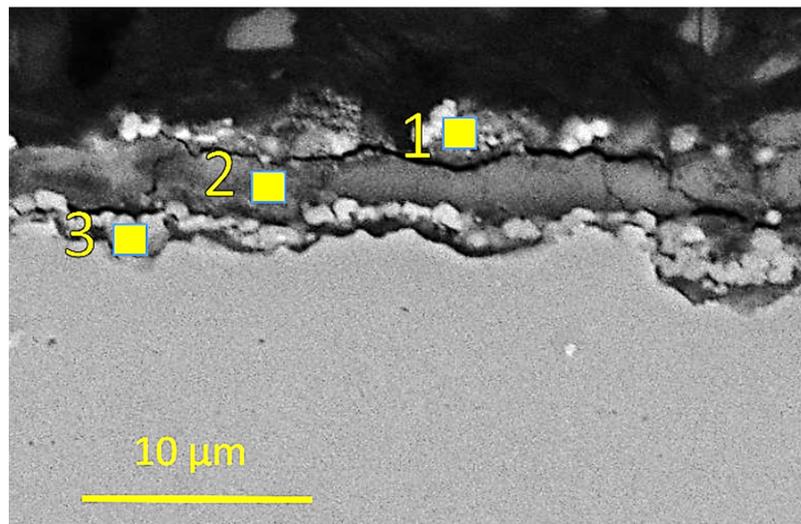
**Figure 11.** Cross-section 3 cm from the outlet end of tested carbon-steel sample 9 at the end of the last reactor (condenser).**Table 11.** Elemental analysis from locations in Figure 11.

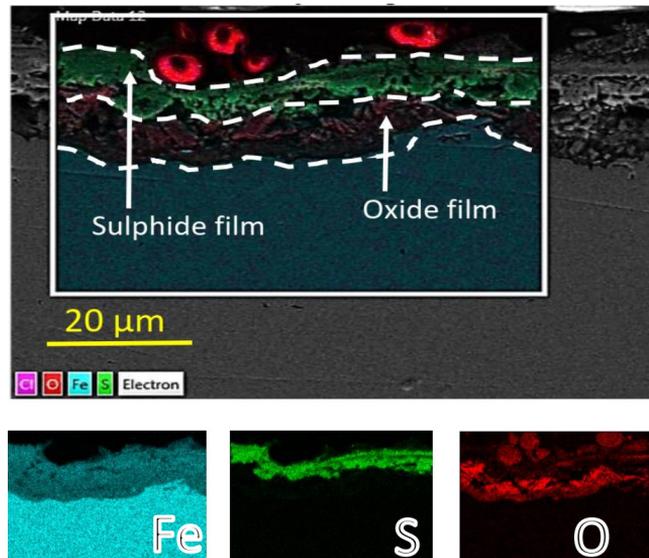
Figure 12. Elemental scanning of cross-section 1 cm from the outlet end of tested carbon-steel sample 9 at the end of the last reactor (condenser).

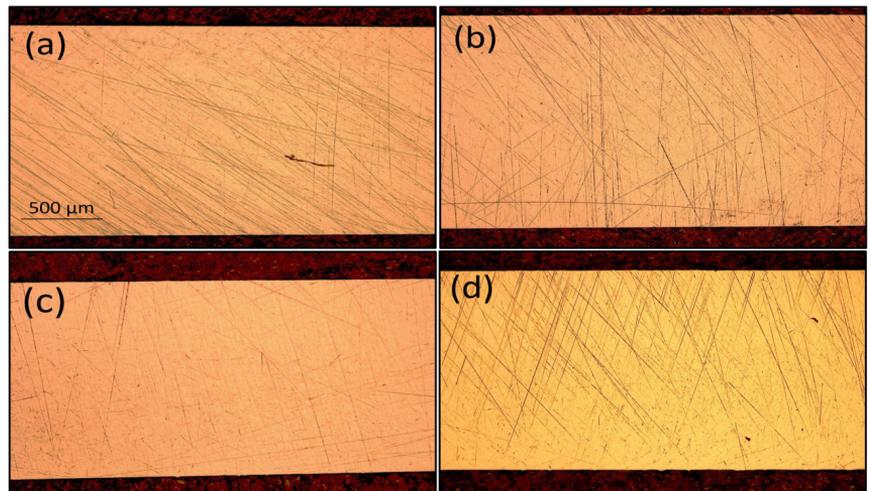
Figure 13. Optical microscope images of the cross-section of the titanium alloy sample (5 \times magnification); (a) 1 cm from the inlet end of sample 1, (b) 3 cm from the inlet end of sample 1 in the first reactor, (c) In the middle of sample 5 in the second reactor and (d) 1 cm from the outlet end of sample 9 in the third reactor.

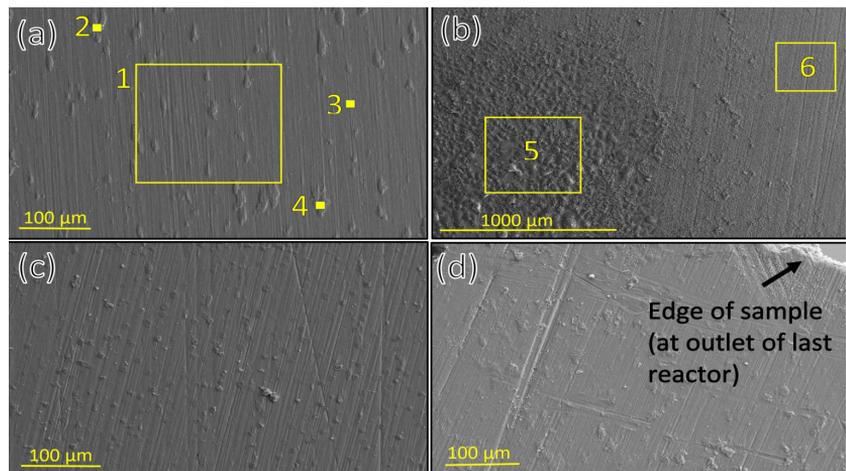
Figure 14. SEM images of the surface of; (a) the untested titanium-based alloy, (b) the tested titanium alloy sample 1, 1 cm from the inlet end in the first reactor, (c) tested titanium alloy sample 1 3 cm from the inlet end of the first reactor and (d) tested titanium alloy sample 9 at the end of the last reactor.

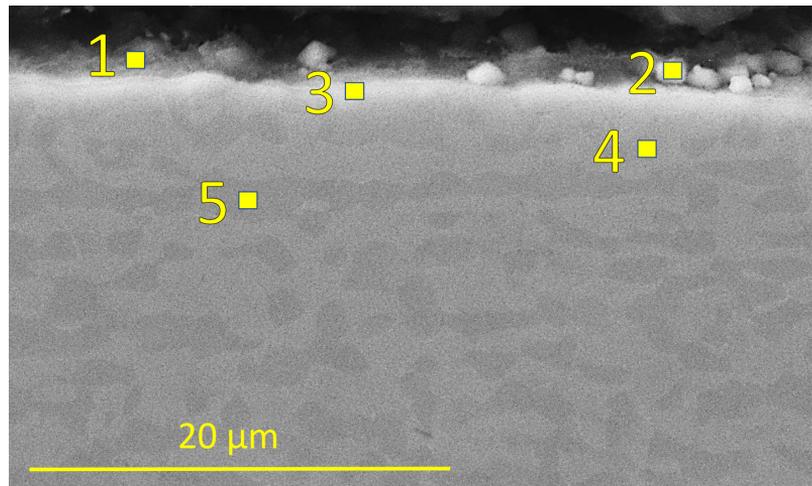
Figure 15. SEM and XEDS analysis of the cross-section of tested titanium alloy sample 1 at 1 cm from the inlet end of the first reactor.

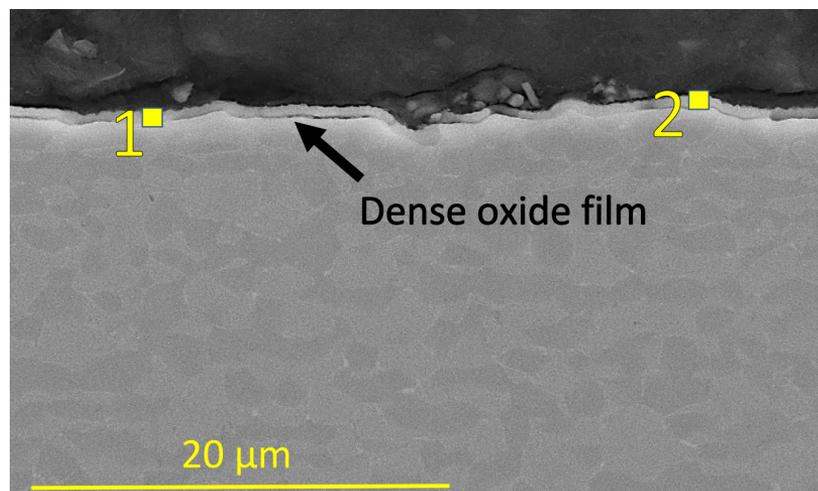
Figure 16. SEM image and XEDS analysis of a cross-section of the middle part of the tested titanium alloy sample 5 in the middle of the second reactor (superheated fluid).

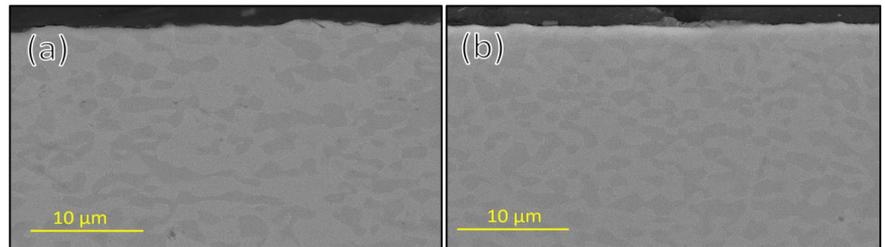
**Figure 17.** SEM and XEDS analysis of the cross-section of tested titanium alloy sample 9 (a) middle of sample 9 and (b) one cm from outlet end in the last reactor.

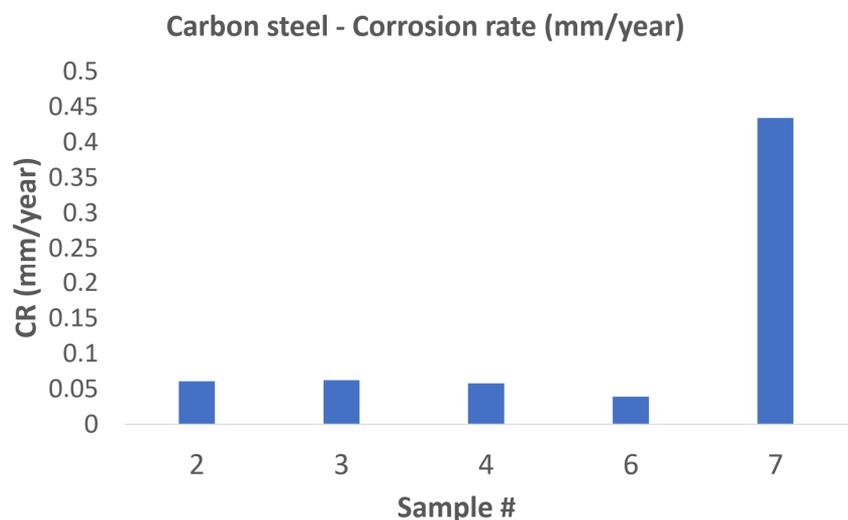
**Figure 18.** Weight loss analysis of carbon-steel samples. Samples 2 and 3 were accommodated in the 1st reactor, samples 4 and 6 in the 2nd reactor and sample 7 in the 3rd reactor.

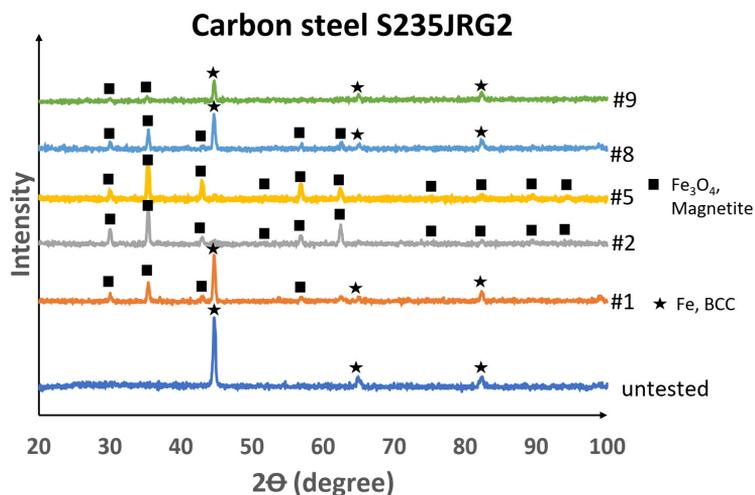
Figure 19. XRD scatters from carbon-steel samples from bottom to top: (untested) Unexposed sample, (1) tested sample at the inlet in the first reactor, (2) tested sample in the middle of the first reactor, (5) tested sample in the middle of the second reactor, (8) tested sample in the middle of the third reactor and (9) tested sample at the outlet of the third reactor.
