Corrosion Behaviour of Materials in High-Temperature Geothermal Environments

**Faculty of Industrial Engineering, Mechanical Engineering
and Computer Science
University of Iceland
2022**

Dissertation submitted in partial fulfilment of a
Philosophiae Doctor degree in Mechanical Engineering

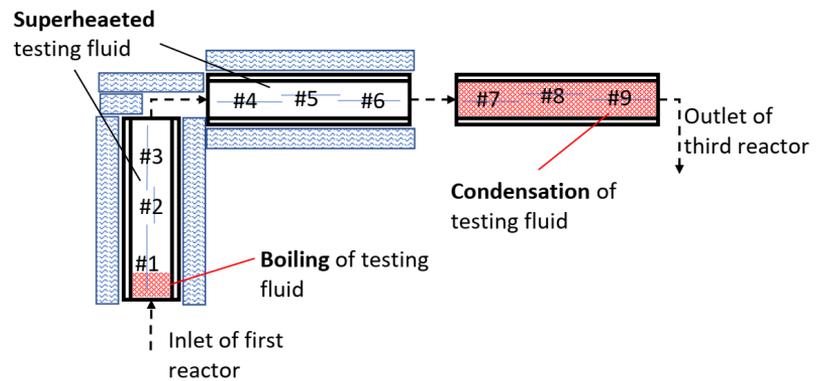
Figure 20. Boiling was thought to have occurred in the volume in the first few centimetres in the first reactor and condensation of testing fluid was thought to have occurred in the third reactor.

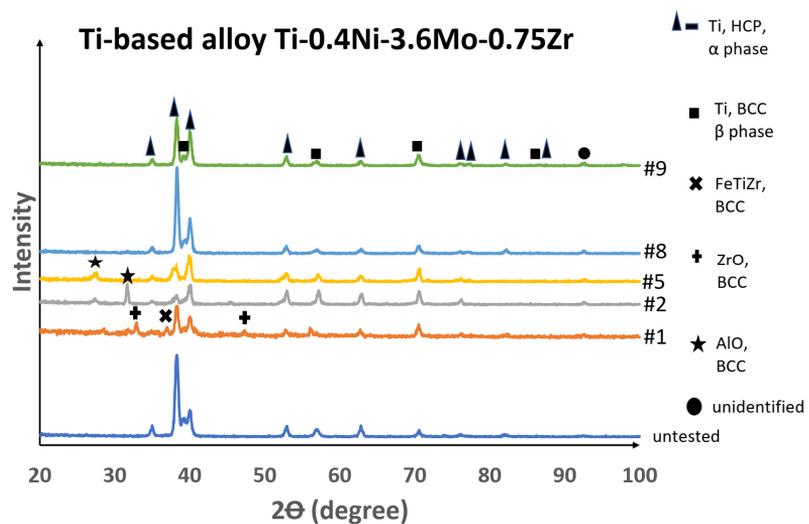
Figure 21. XRD scatters from the titanium alloy from bottom to top: (untested) Unexposed sample, (1) tested sample at the inlet in the first reactor, (2) tested sample in the middle of the first reactor, (5) tested sample in the middle of the second reactor, (8) tested sample in the middle of the third reactor and (9) tested sample at the outlet of the third reactor.

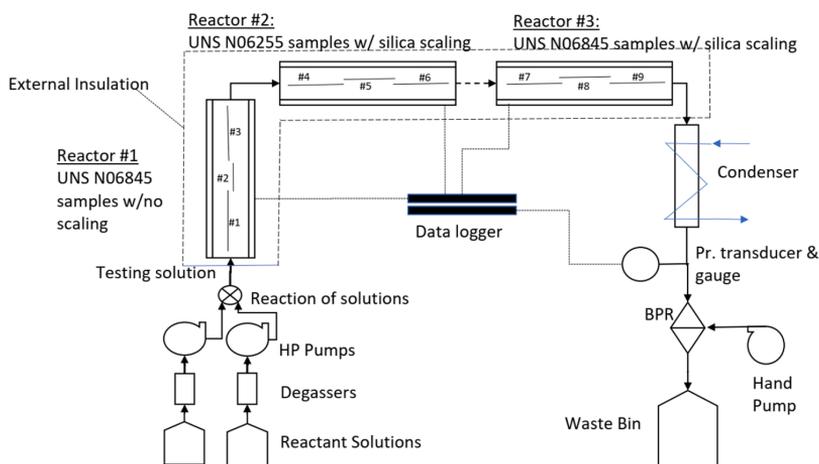
Fig. 1. A schematic diagram of the experimental apparatus used for the corrosion testing.

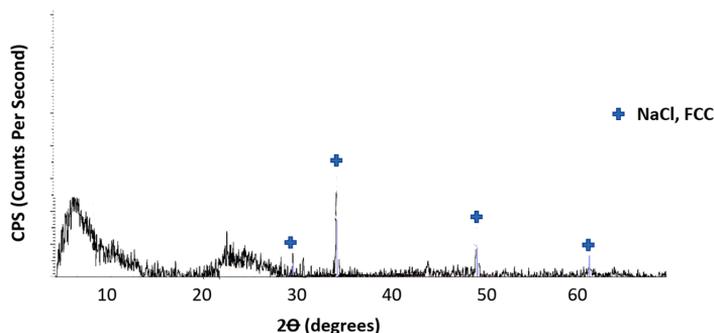
Fig. 2. Filtered XRD scatter from the finely ground geothermal scaling powder.

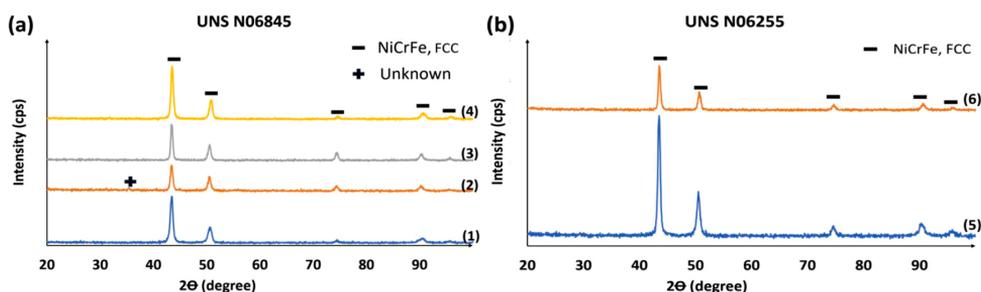
Fig. 3. (a) UNS N06845; (1) Untested UNS N06845, (2) tested UNS N06845 with no silica scaling one cm away from the inlet of the first reactor (sample #1), (3) tested UNS N06845 with no silica scaling five cm away from the inlet of the first reactor (sample #1) and (4) tested UNS N06845 with silica scaling in middle of the third reactor (sample #8). (b) UNS N06255; (5) untested UNS N06255 and (6) tested silica-coated UNS N06255 in the second reactor (sample #5).

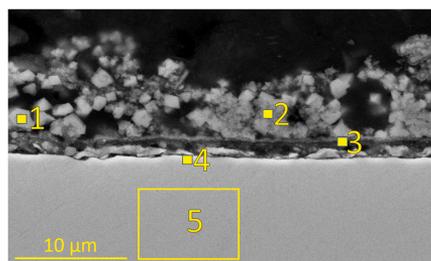
Fig. 4. Cross-section of sample #1, UNS N06845 without silica scaling, 1 cm away from the inlet of the first reactor.

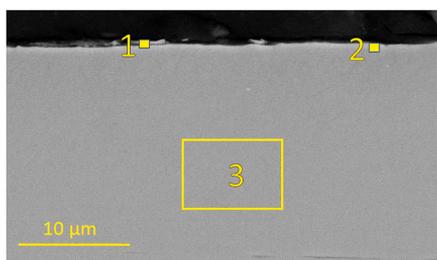
Fig. 5. Cross-section of sample #1, UNS N06845, in the middle of the sample in the first reactor (boiler).

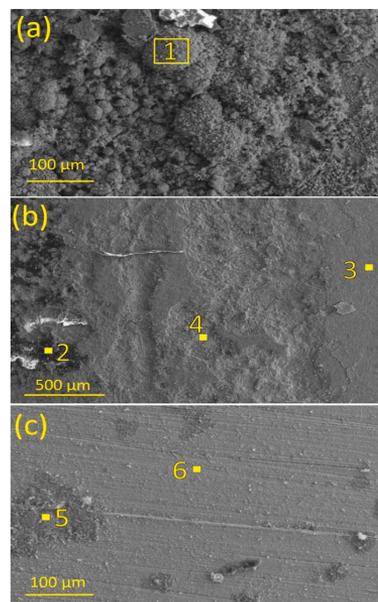
Fig. 6. The surface appearance of sample #1, UNS N06845 without silica scaling, (a) one cm from the inlet, (b) five cm from the inlet, and (c) ten cm from the inlet in the first reactor.

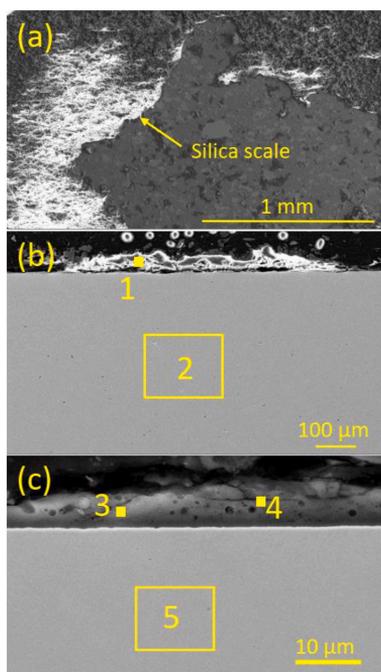
Fig. 7. a) Silica coverage of the surface of UNS N06255 samples in the second reactor, (a) part of the external surface on sample #4; and (b)-(c) cross-sections of sample #5.

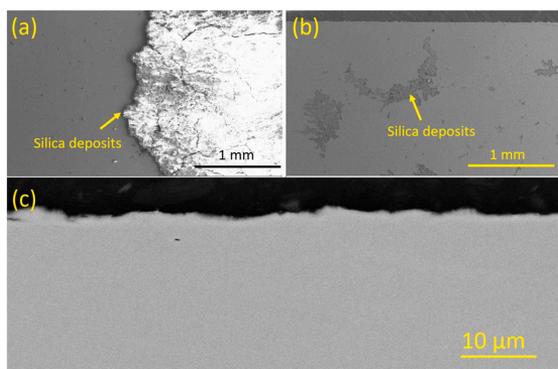
Fig. 8. a) Silica scaling remained on only part of the surface of UNS N06845; part of external surface of (a) sample #7 and (b) sample #8 and (c) cross-section in sample #8.
