## **ANALYSING AND MODELLING RECORDED EARTHQUAKE INDUCED STRUCTURAL RESPONSE**

**Jonas Thor SNÆBJORNSSON<sup>1</sup>, Athol J. CARR<sup>2</sup> and Ragnar SIGBJORNSSON<sup>3</sup>,**

### **SUMMARY**

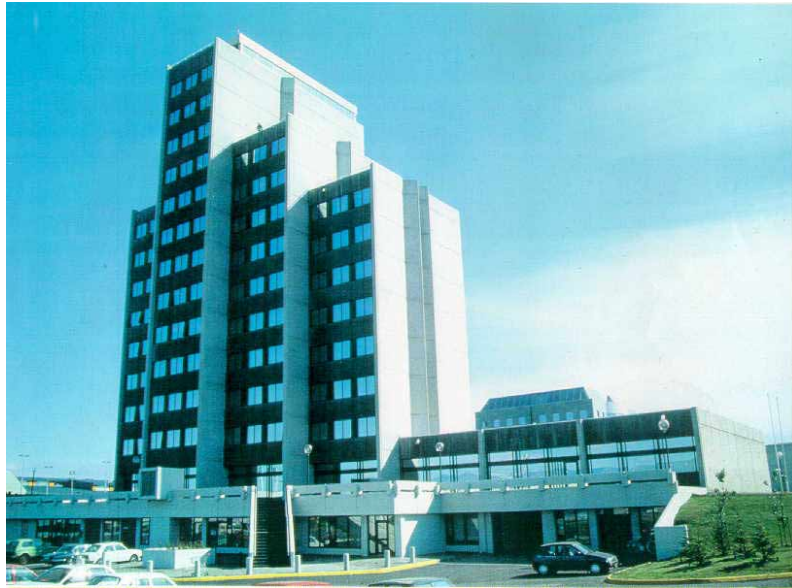
Figure 1. The Commerce Building in Reykjavik, view from Northwest.

The Commerce Building in Reykjavik is 14 stories high (45 m) office building. It is a reinforced cast-in-place concrete structure, basically composed of shear walls and slabs. The geometry of the building is rather complex, as the floor plans vary, changing vertically, as shown in figure 1 and 2. The 14<sup>th</sup> floor plan is about 8 m wide and 18 m long. The alignment of the building is such that the translational modes of vibrations are approximately in the ESE-WNW and NNE-SSW directions. Some earlier investigations of the building and its response to wind and earthquake excitation have been reported [8,10].

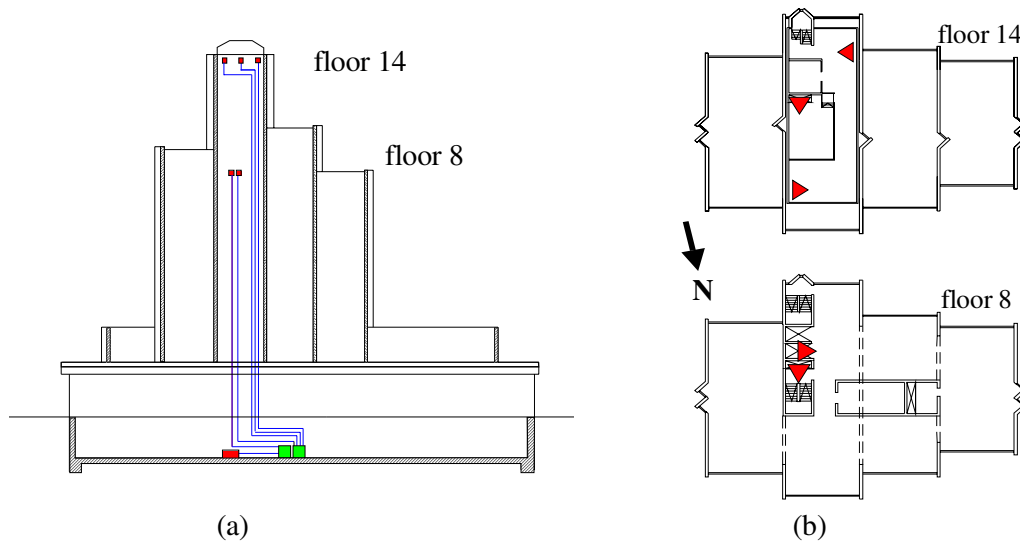
Figure 2. The instrumentation arrangement: (a) Vertical section, and (b) Floor plans of the building, showing the location of instrumentation (▲ uni-axial accelerometer, ■ tri-axial accelerometer and ■ data acquisition).

The building was instrumented in January 1989. The instrumentation is located at three levels (see figure 2): the basement, the 8th floor and the 14th floor. A tri-axial accelerometer (Kinematics FBA-23) is located in the basement, measuring the three components of base (ground) acceleration. On the 8th floor two uni-axial accelerometers (Kinematics FBA-11) are located measuring the two horizontal components of the response. On the 14th floor (the top floor) three uni-axial accelerometers are located, one measuring motion in the N-S direction and two measuring in opposite corners (i.e. N-E and S-W) measuring motion in the E-W direction. This makes it possible to detect torsional effects on the 14th floor (see figure 2). The

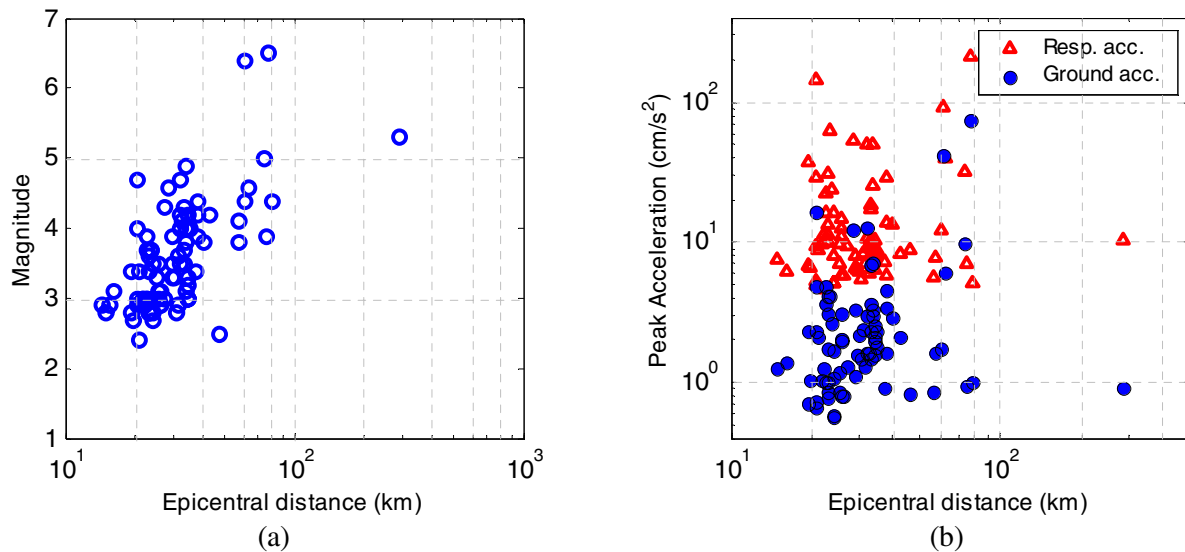
**Figure 4.** (a) Magnitude as a function of epicentral distance to the Commerce building and (b) the corresponding PGA values and peak response acceleration as a function of epicentral distance.

The system has recorded 78 earthquakes at all eight channels. The recorded earthquakes range in magnitude between 2½ and 6½. Figure 3 and 4 gives an overview on the recorded earthquakes. The geographic location of the EQ epicentre is shown on figure 3 in relation to the location of the building. Figure 4 shows the earthquake magnitude and maximum horizontal ground and response acceleration as a function of epicentral distance. The acceleration values shown are based on time-series, which have been corrected and filtered to account for the characteristics of the sensors, noise, zero offset and drift. It should be noted, that earthquakes often occur in sequence, in which case several events are recorded within a time frame of few days or less.

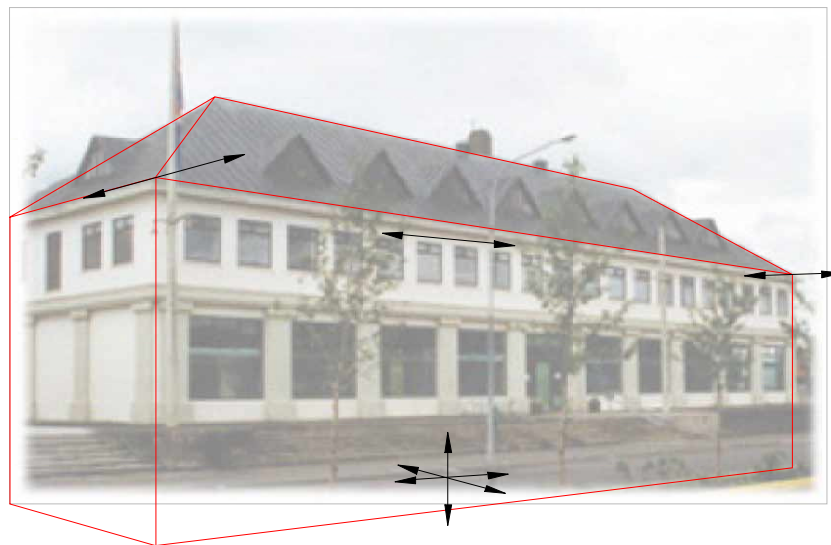
**Figure 6. The Town Hall at Selfoss, view from Northeast. The black arrows indicate location and directionality of the accelerometers.**

The Town Hall at Selfoss (see figure 6) is an office building with 3 stories and a basement. It is about 11 m high from ground level to the rooftop, and about the same distance from the basement floor to the top floor. Its rectangular plan is about 38 m long and 10 m wide. It is a reinforced cast-in-place concrete structure, composed of outer shear walls and a shear core around the stairway and elevator shaft, but with two rows of interior concrete columns and interconnecting floor beams to carry the slabs (see figure 7). The orientation of the building is such that the length of the building approximately aligned along an ESE-WNW axis. This building was built in the 1940s in wartime conditions and the available drawings do not indicate exactly the location or the amount of reinforcement. The building was retrofitted and renovated during the period 1997 to 2001. The EQ retrofitting included additional concrete shear wall units strategically placed to improve the structural behaviour and enhance the strength of the building. Also two steel cross-braces were inserted into the window frames at ground level on the north side.

The building was instrumented in January 1999. The instrumentation is located at two levels (see figure 5 and 6): the basement, and top storey (the 3<sup>rd</sup> floor if the ground floor is no. 1). A Kinemetrics-K2 digital recorder with an internal tri-axial accelerometer is located in the elevator shaft in the basement, measuring the three components of base (ground) acceleration. On the top floor three uni-axial accelerometers are located, one measuring motion in the E-W direction and two measuring in opposite corners (i.e. N-W and S-E) measuring motion in the N-S direction. This makes it possible to detect torsional effects. The uni-axial sensors (channels) are connected to the K2 digital recorder in the basement. The sampling rate is 200 Hz. The data acquisition starts automatically when the acceleration exceeds a specific trigger level, which can be defined for each channel (0.05-0.075%g in the basement, 0.20-0.25%g on the top floor).

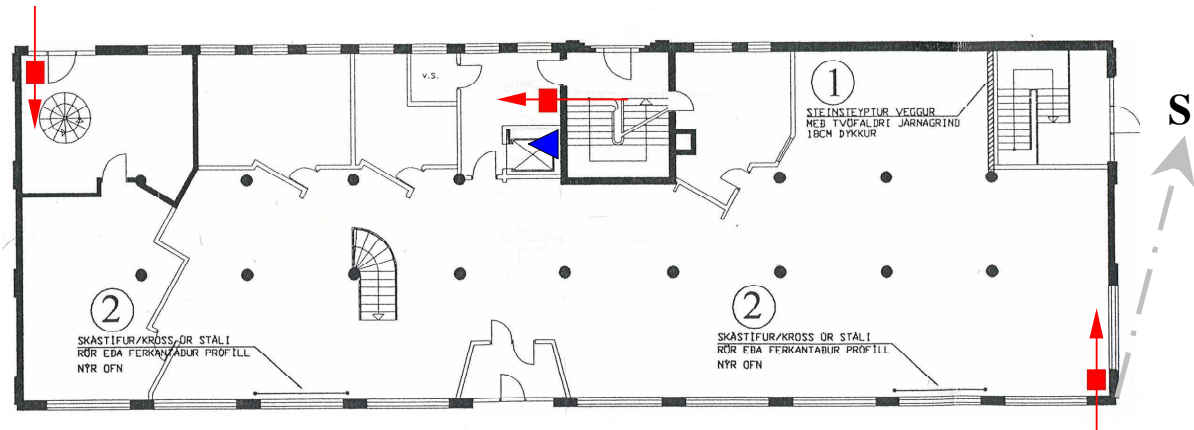
**Figure 7. The Town Hall at Selfoss, plan view of the ground floor. The location of uni-axial (squares) and tri-axial (triangle) accelerometers within the building plan as well as their positive direction is shown. The location of steel cross-braces (2) and reinforced concrete wall (1) installed in spring 2000 for retrofitting purposes can also be seen.**

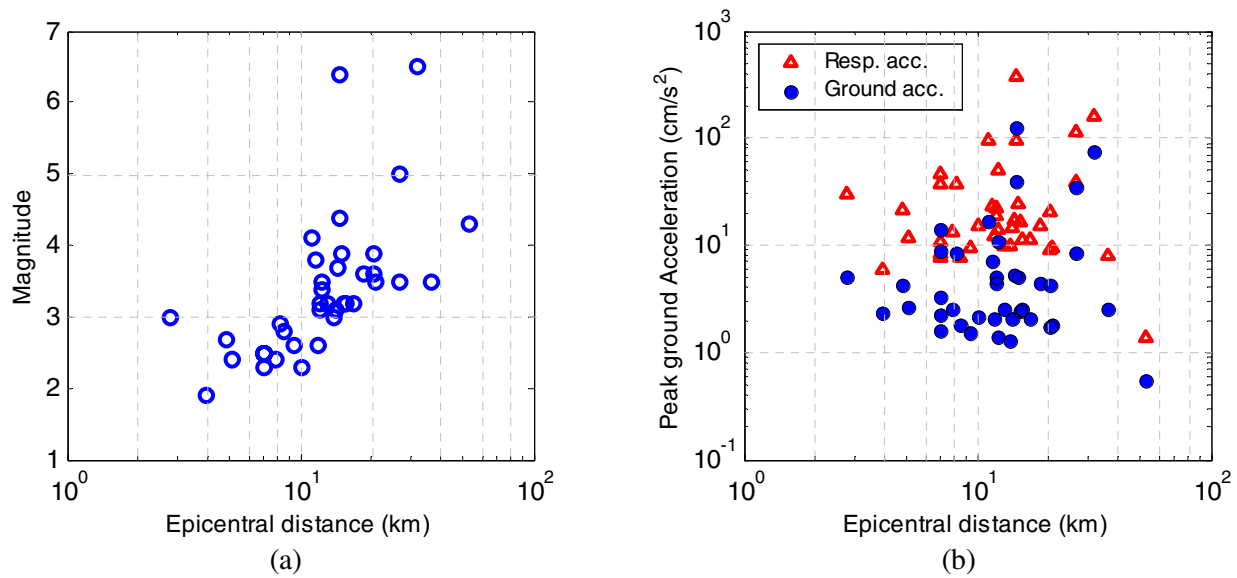
**Figure 9. (a) Magnitude as a function of epicentral distance to the Selfoss Town Hall and (b) the corresponding PGA values and peak response acceleration as a function of epicentral distance.**

The system has recorded 40 earthquakes at all six channels. The recorded earthquakes range in magnitude between 2 and 6½. Figure 8 and 9 give an overview on the recorded earthquakes. The geographic location of the EQ epicentre is shown on figure 8 in relation to the location of the building. Figure 9 shows the earthquake magnitude and maximum horizontal ground and response acceleration as a function of epicentral distance.

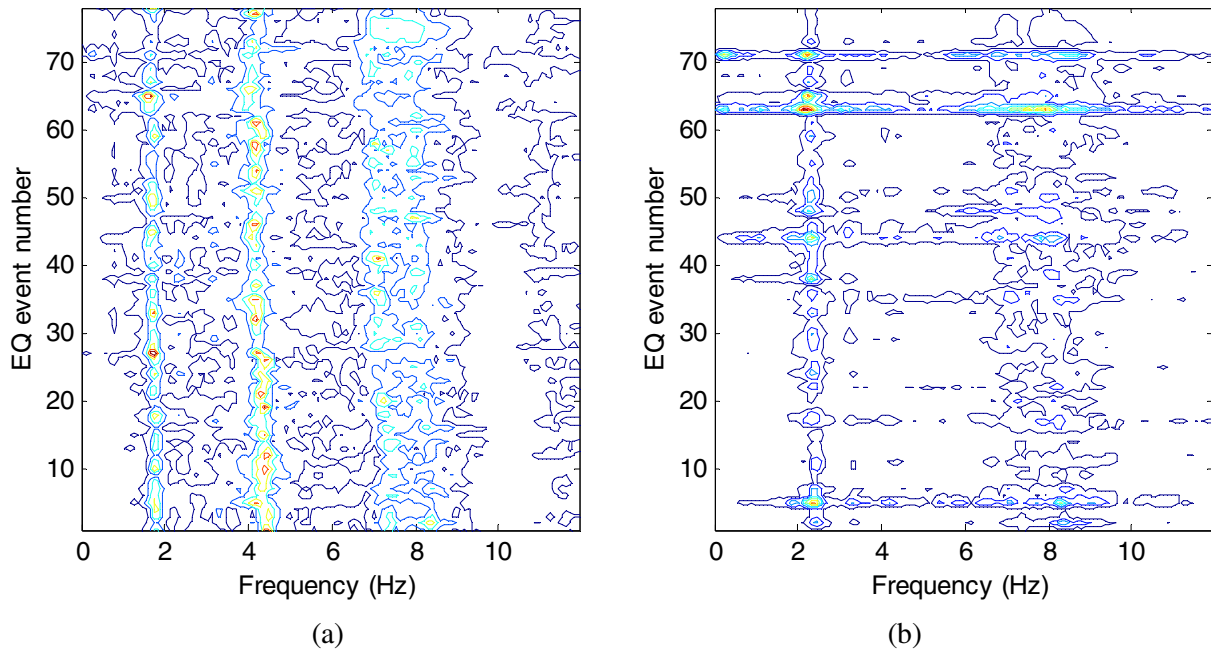
**Figure 10. Contour graphs of the Fourier spectrum for the 78 events analysed. (a) For vibration in the ESE-WNW direction. (b) For vibration in the NNE-SSW direction.**

The records from the Commerce building were analysed in a sequentially, in order to establish a temporally organised database of system parameters. Figure 10 gives an overview on the modal frequencies. There are three modes strongly excited during vibration in the ESE-WNW direction, just below 2 Hz, just above 4 Hz and at 8 Hz. For vibration in the NNE-SSW direction, two modes dominate the response, at just above 2 Hz and at 8 Hz. The irregular shape of the building along with the asymmetric location of the shear-core around elevators and staircase in the centre tower makes all modes influenced by torsion.

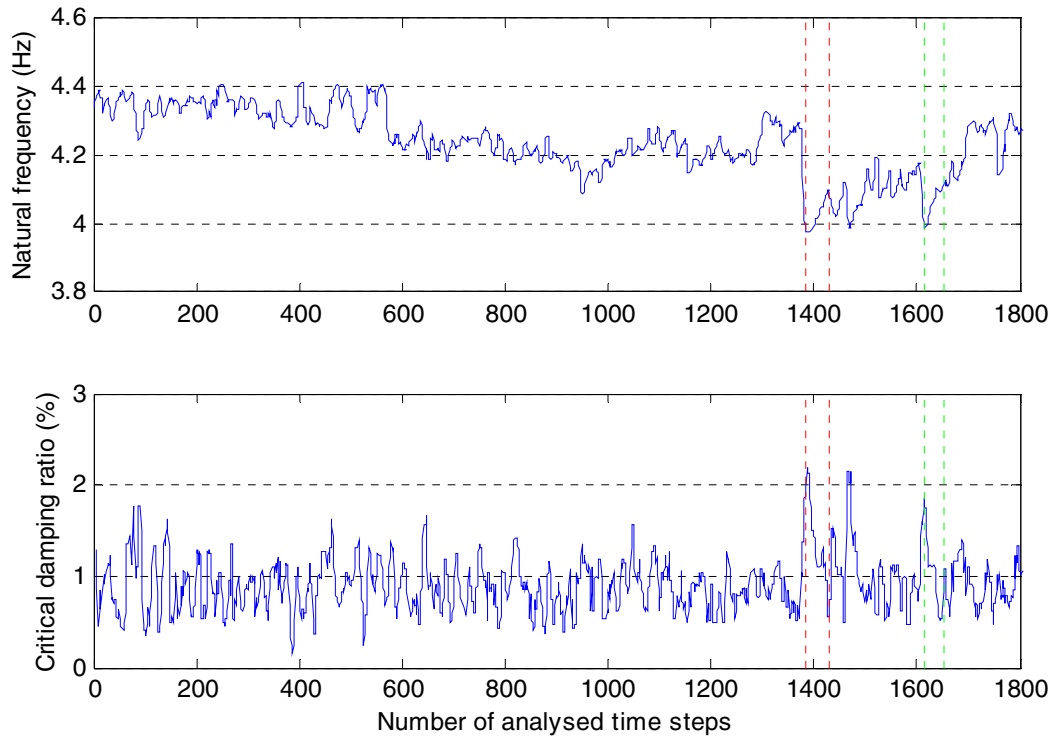
**Figure 11. Natural frequency and critical damping ratio as a function the number of analysed time steps. The 6.5 magnitude events of June 17 and June 21 in 2000 are indicated within the dotted stripes, red and green, respectively.**

Figure 11 gives an example of the evolution and variability in the system parameters for the second ESE-WNW mode in the 78 events recorded during a 14 years observation period. The ‘time-series’ shown are a smoothed version of the estimated parameters to give a visually clearer picture. The damping is seen to

vary from 0.5% for low amplitude data up to 1.5% and higher for the high amplitude data such as the two 6.5 magnitude events. The frequency is also seen to vary considerably, or from 4.4 Hz down to 4 Hz. Also, there are conceivably indications of a long-term reduction in the natural frequency. Looking at the large events, marked by the vertical grid lines, it is seen that although the natural frequency seems to be re-established at 4.2-4.3 Hz, it takes the structure a considerable time to reach that point. Especially considering that 8 smaller events are recorded during the 4 days between 17 and 21 of June. Another 6 events are recorded in the period after that, in July and November 2000 and then two in 2001. This indicates that the ‘rebound’ of a structure undergoing excitation, seemingly within the linear range of response, is not instantaneous but a process that may take few days, weeks or longer.

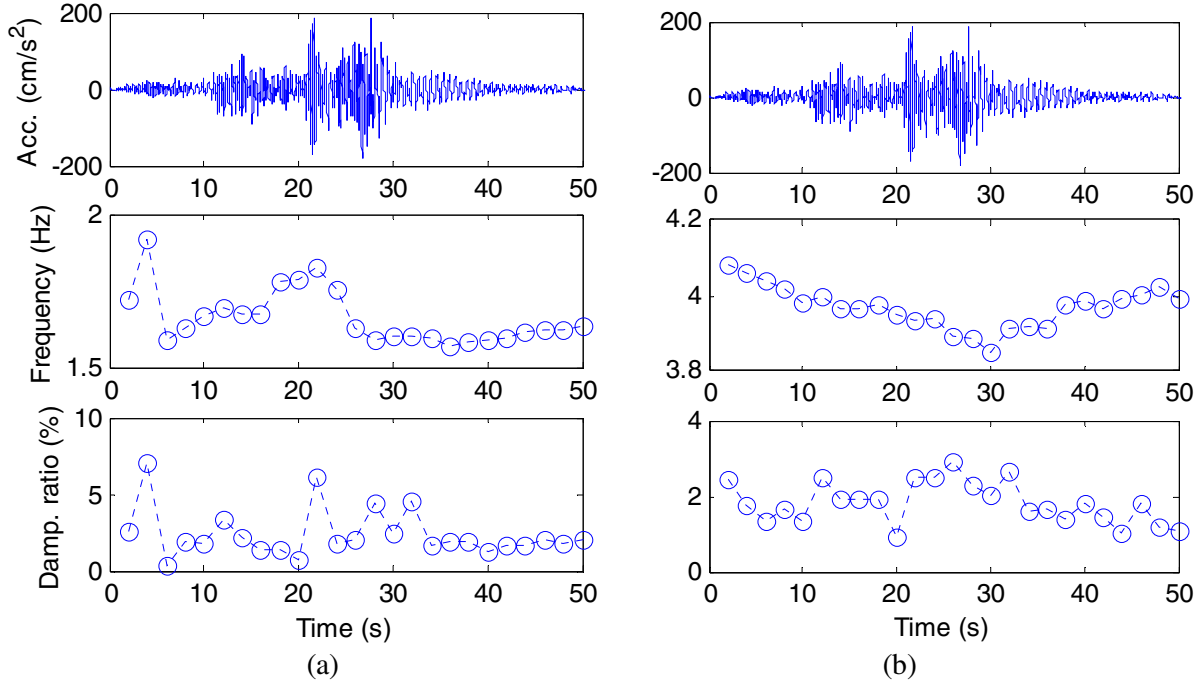
**Figure 12.** The acceleration time series from the June 17 main event along with the frequency- and damping sequence from the same event for (a) the first and (b) the second mode of E-W vibration.

The time-series of natural frequency show partly how the frequency changes with amplitude but also how that the participation of the modes varies throughout the earthquake. The second mode is clearly

increasingly active throughout the peak of the earthquake and then its participation reduces and the frequency increases towards its starting value. On the other hand, the first mode starts out strong, then its participation reduces while the first arriving waves of higher frequency content have passed, at which time its participation increases again and dominates the decay of the motion. The estimated damping is bit chaotic, but is in general seen to increase as the amplitude increases. The variation is seen to be greater for the first mode, where the damping repeatedly exceeds 5% of critical, while the damping of the second mode is more stable around 2%. This is not unreasonable as damping is generally related to velocity or displacement controlled processes [11], and both velocity and displacement are considerably larger for the first mode than the second.

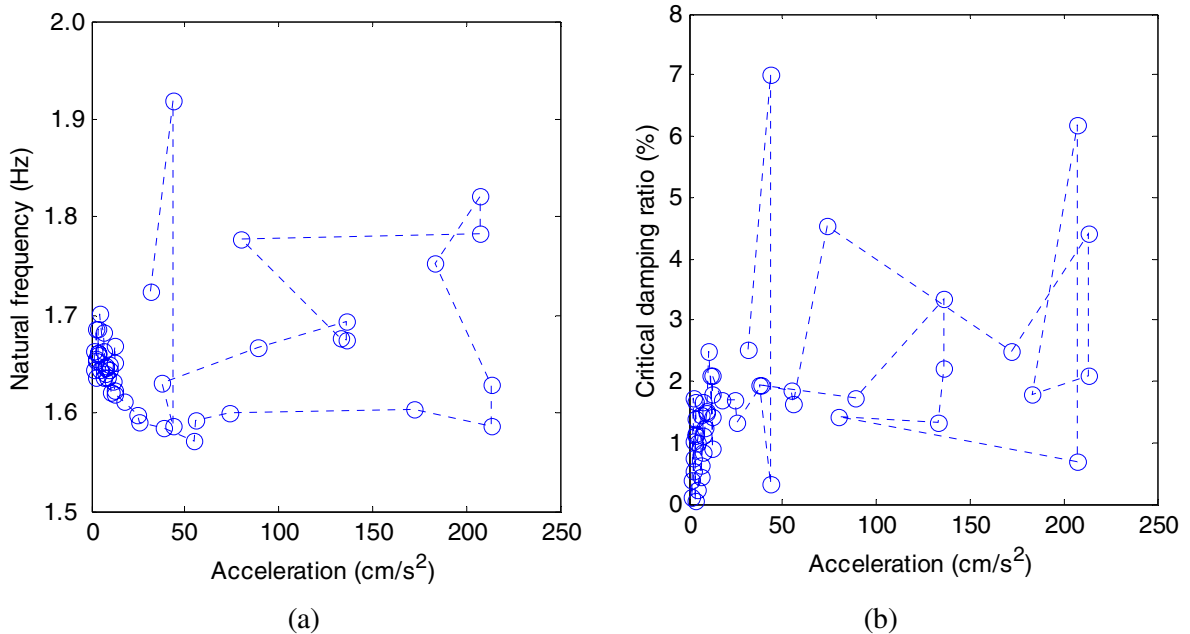
**Figure 13.** Natural frequency (a) and critical damping ratio (b) for the first mode of E-W vibration as a function of acceleration amplitude during the June 17 main event.

Plotting natural frequency and critical damping ratio versus the peak acceleration amplitude for each time-step within the event, gives another view on how the SI-parameters are changing during the earthquake. This is done in figure 13 for the first E-W mode of vibration. The result is a trace that in some ways resembles a displacement trace during a non-linear response. This underlines the fact that it is not just the overall amplitude of motion that affects the SI-parameters, but rather the relative contribution of the modes of vibration at each time step.

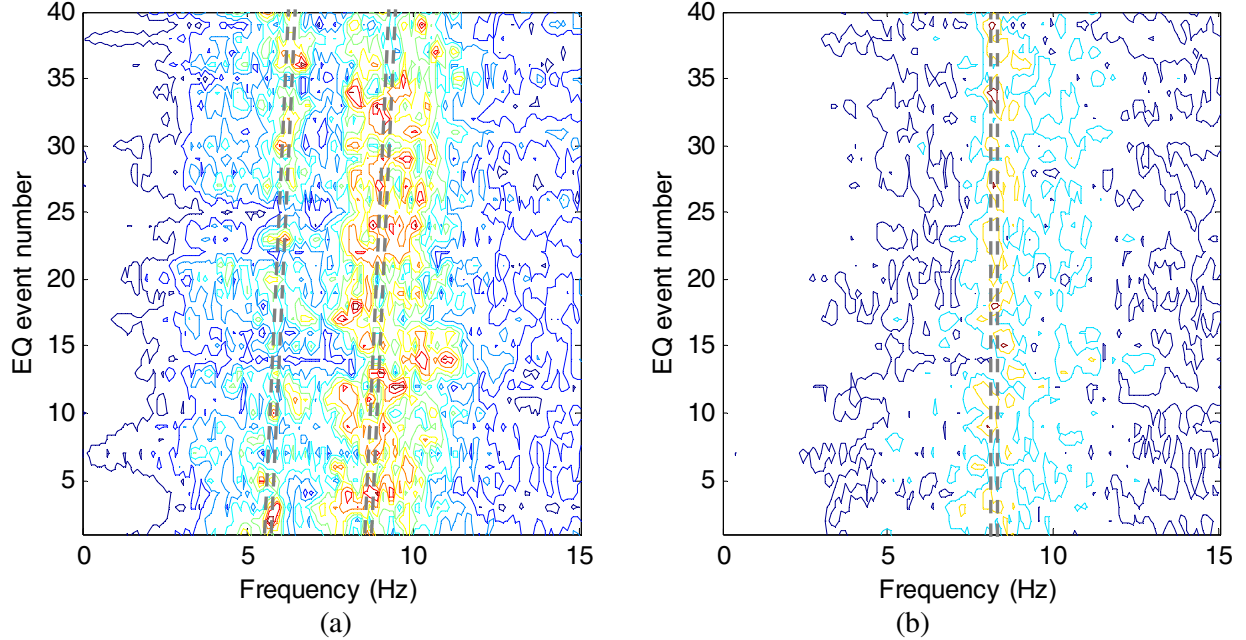
**Figure 14. Contour graphs of the Fourier spectrum for the 40 events analysed. (a) Vibration in the NNE-SSW direction. (b) Vibration in the ESE-WNW direction. The double dotted lines point out the slight drift in natural frequency of each mode of vibration throughout the observation period.**

The records from the Selfoss Town Hall building were analysed in a similar fashion as the Commerce Building, but the two buildings represent two different cases. Figure 14 gives an overview on the primary modal frequencies. It can be seen that it is difficult to identify clearly the modes of vibration in the NNE-SSW direction. Something is going on at about 6 Hz and then again between 8 and 10 Hz. For vibration in the ESE-WNW direction there is basically one mode at about 8 Hz that dominates the response. The asymmetric location of the shear-core around the staircase along with irregular distribution of shear walls along the NNE-SSW axis and large windows on the North side at the ground floor level makes all the modes linked with torsion. In fact frequency response is detected at similar frequencies for perpendicular acceleration signals and it is difficult to distinguish between or decouple the translational motion and the torsional motion. Another observation, when looking at figure 14, is that the central frequencies of the active frequency ranges representing the modes of N-S vibration are not constant but slightly increasing throughout the observation period. This is demonstrated with the double dotted lines drawn across the contour plots.

After some investigation it was determined that there were basically three active modes of vibration in the ESE-WNW direction, i.e. at 6 Hz, 8 Hz and 10 Hz. The randomness in the frequency response depicted in figure 14 is most likely caused by the fact that the retrofitting elements are not fully integrated into the structural system of the building and their resistance, or activeness, can therefore be expected to vary considerably depending on the amplitude and character of both excitation and response. The slight increase in frequency throughout the observation period is similarly likely to be caused by a gradual unification between the original structure and the retrofitting elements. Any small gaps, due to shrinkage in the later inserted wall, will result in a not fully functional element at small displacements associated with lesser earthquakes. Repeated grinding of the walls during earthquakes may slowly fill the gaps. Secondly, the retrofitted walls will stiffen with age as the concrete continues to cure.

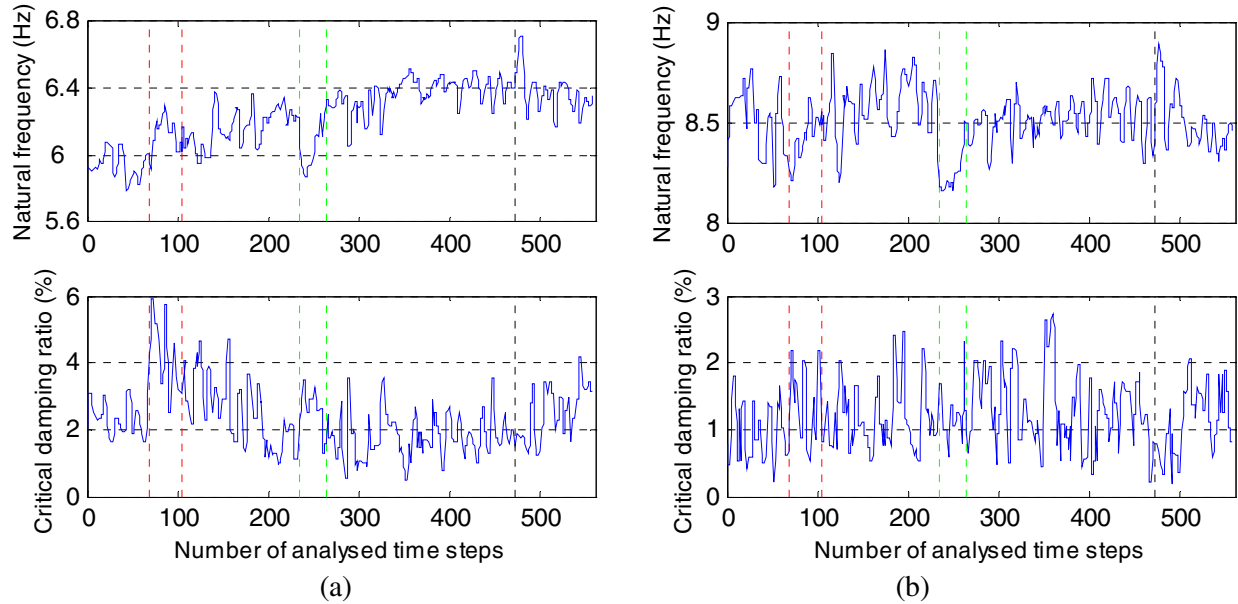
**Figure 15. Natural frequency and critical damping ratio as a function the number of analysed time steps for: (a) N-S mode of vibration at 6 Hz and (b) E-W mode of vibration at 8.5 Hz. The June 17 and June 21 events are enclose by the red and green dotted stripes, respectively, while the black dotted line marks the end of the July 26 EQ, the final event in the summer of 2000.**

Figure 15 shows the development and changes in the system parameters for a N-S mode of vibration at 6 Hz and an E-W mode of vibration at 8.5 Hz during a 4 years period with 40 recorded events. The development of these two modes is somewhat different. The frequency for the N-S mode (figure 15a) is increasing throughout the observation period, whereas the E-W mode (figure 15b) has a more constant frequency. The damping for N-S mode seems to be decreasing throughout the summer of 2000 until it stabilises at about 2%, whereas the damping for the E-W mode varies around a relatively constant mean value. The damping values are in general agreement with the findings of [4]. As mentioned before, the

trends seen in the N-S mode are likely caused by a gradual locking between the original structure and the retrofitting elements. The majority of the retrofitting wall elements have a N-S orientation and their primary purpose is to reduce rotational effects and translational response along the N-S axis. These additional elements should therefore not have significant effect on the E-W modes of vibration, which is supported by the data.

The noticeable changes after July 2000 (see the black dotted line in figure 15) are due to the fact that the top floor was being renovated and had been stripped of all partitions and furniture and a 2.5 cm levelling layer had been removed from the concrete floor. During the renovation process the top floor was strengthened with a 5 cm reinforced concrete layer. The data recorded after the renovation shows again increased damping and decreased frequency due to the added mass from a thicker floor and heavy double gypsum partitions.

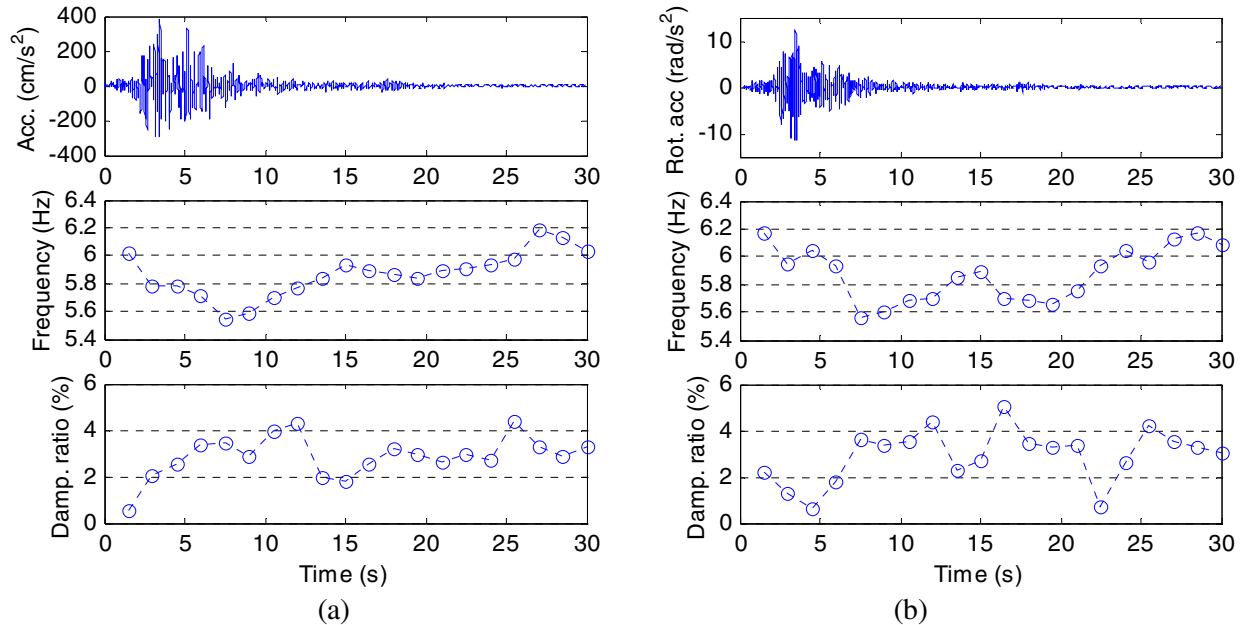
**Figure 16. The acceleration time series from the June 21 main event along with the frequency and damping ‘time-series’ from the same event. (a) For the first mode of N-S vibration and (b) for the rotational part of the same mode of vibration.**

During the 6.5 magnitude earthquake on June 21 in 2000 [14], which had an epicentre about 15 km east of the Town Hall, the acceleration levels at the top floor reached about 39% g. An acceleration time series recorded during that earthquake is displayed in figure 16, which shows the observed N-S response of the NE corner on the top floor. The overall N-S acceleration is shown on figure 16a and the rotational component on figure 16b. The N-S direction lies across the weaker axis of the structural system, therefore the building response is highest for that direction. The frequency content of the acceleration changes throughout the earthquake. The time-series of natural frequency show how the frequency changes with amplitude. The natural frequency related to rotation seems to be slightly higher during the first 6 s of the EQ, but the frequency in both data series is seen to decrease as the amplitude of motion increases and then as the motion decrease the frequency level stabilises at about 6.1 Hz. An interesting observation considering the damping is that as the acceleration is reaching its peak the damping related to rotation is decreasing while the overall damping is increasing with increased amplitude of motion.

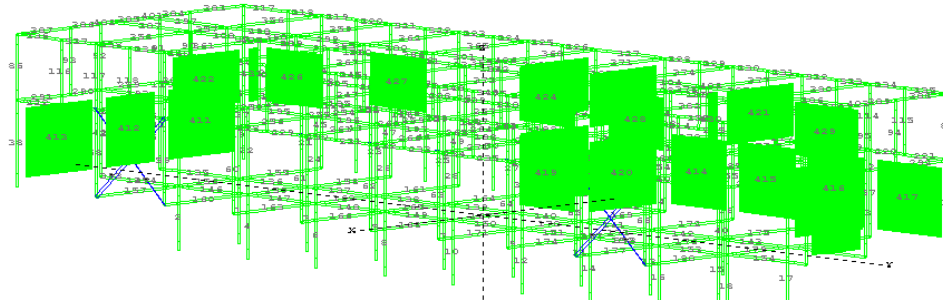
**Figure 17. Overview of the building model.**

The analysis was undertaken using the RUAUMOKO3D program [2], which is designed to undertake dynamic elastic and inelastic analysis of structures subjected to earthquake and other dynamic loadings [7]. The mesh of the model for the Town Hall building is shown in figure 17. It includes 251 nodes and 431 elements: beams, columns, wall units. The roof structure is not included in the model, but the roof mass is

applied as point mass to the column tops. The two upper floors are modelled as rigid diaphragms. The model was found to represent the actual geometry and the structural behaviour adequately.

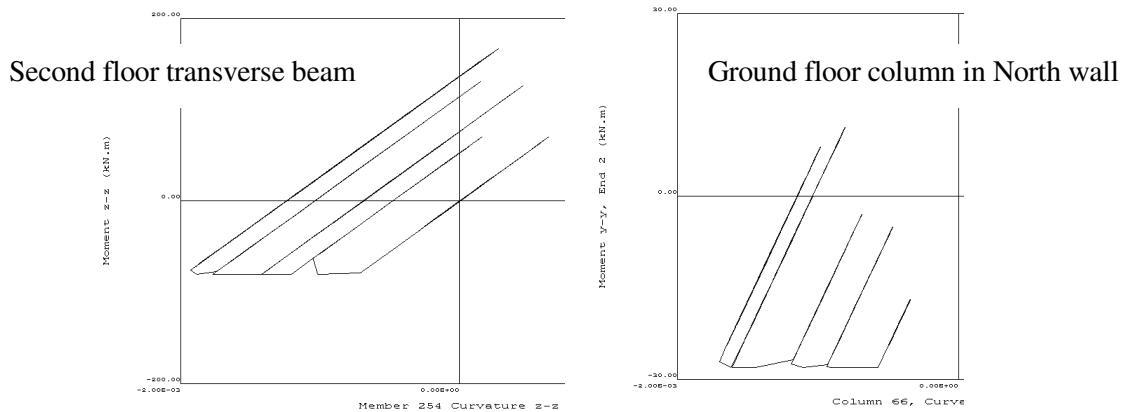
**Figure 19. Hysteresis loops for a second floor transverse beam and for a ground floor column in the north wall.**

For the event studied, the structure is essentially elastic with only a small degree of in-elastic behaviour indicated in few elements on the ground and first floor. The critical elements are the columns in the ground floor North wall and the first floor transverse beams. Figure 19 shows the hysteretic behaviour for these elements. Both hysteresis loops show a largely one-way action with progressive ratcheting of the curvatures. The stiffness difference between the two elements is reflected in the slope of the hysteresis loop.
